GROUP  
Safety Recall Campaign

MODEL  
2013-2014MY  
Optima (QF)  
2.4L/2.0L-T GDI

NUMBER  
SC187 (Rev 3, 03/30/2022)

### LOW-PRESSURE FUEL FEED TUBE REPLACEMENT (SC187)

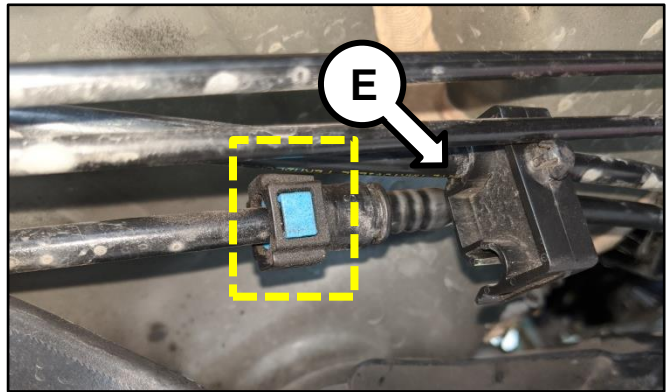
This bulletin provides the procedure to replace the low-pressure fuel tube assembly on some 2013-2014MY Optima (QF) vehicles produced at KMMG from November 15, 2012 through December 18, 2013. The material of the low-pressure fuel tube may deteriorate over time and develop a crack from exposure to heat generated within the engine compartment under certain circumstances. If the fuel tube develops a crack, a fuel smell and eventually a fuel leak can occur. A fuel leak increases the risk of a fire. Dealers are to replace the low-pressure fuel tube as outlined in this bulletin. Before conducting the procedure, verify that the vehicle is included in the list of affected VINs.

- 9a. Detach the fuel line (E) from the retaining bracket.
- 9b. Press the blue tabs to disconnect/release and remove the fuel line (E).
