GROUP Safety Recall Campaign	MODEL 2013-2014MY Optima (QF) 2.4L/2.0L-T GDI
	NUMBER SC187 (Rev 1, 07/09/2020)	DATE June 2020

SAFETY RECALL CAMPAIGN

SUBJECT: LOW-PRESSURE FUEL FEED TUBE INSPECTION AND REPAIR/REPLACEMENT (SC187)

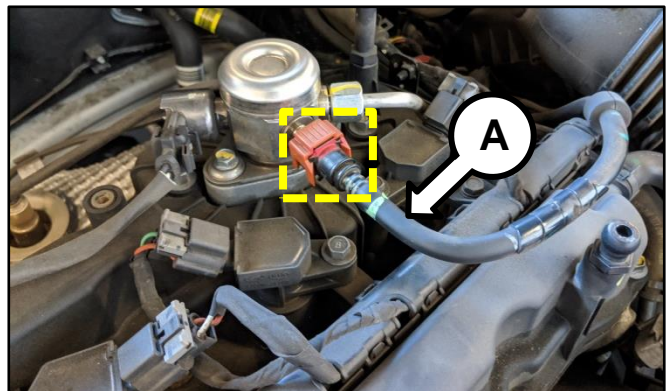
- 2a. Locate the fuel line (A) connector and visually inspect for leak in the outlined area shown.
- 2b. If fuel line IS leaking, refer to page 5 to replace the fuel line.
- 2c. If fuel line is NOT leaking, proceed to step 3 for further inspection.

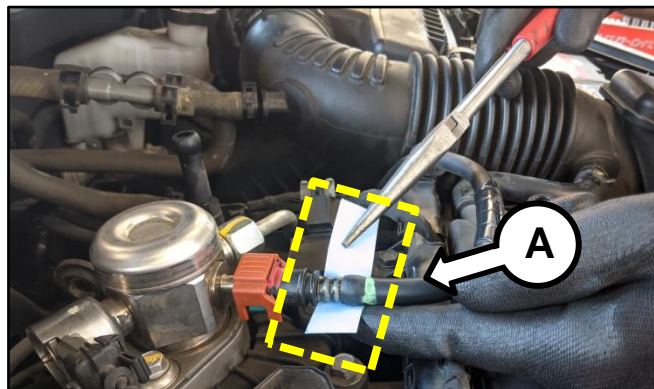
- 3a. Start the engine and allow it to idle.
- 3b. Place the test paper under the fuel line (A) connector area shown and check for moisture on the paper, indicating presence of a leak.
