# Safety Recall

## Code: 36A1

<b>Subject</b>	Steering Shaft Bolt																							
<b>Release Date</b>	March 24, 2020																							
<b>Affected Vehicles</b>

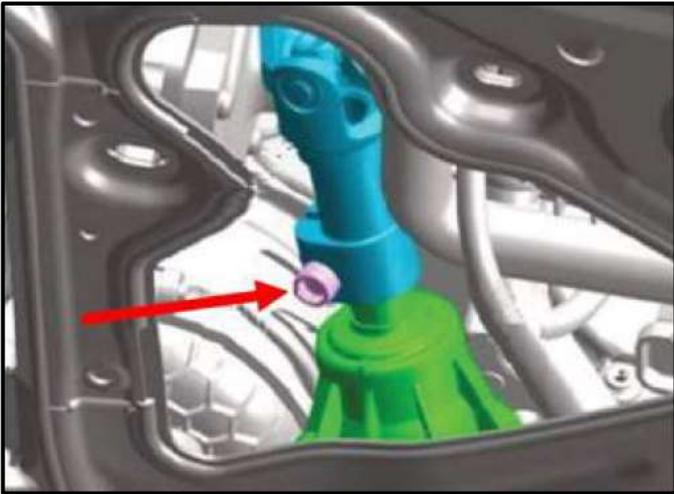
- Inspect steering shaft bolt <arrow> and replace if necessary.
