Safety Recall Action Notice 574 Issue 1 - 03.2020

Subject: Ignition Switch Subharness Routing			
Bulletin Number	Models Affected	VIN Range	Markets Affected
574	Trophy, Trophy SE	From VIN 561284 to VIN 795295	All Markets

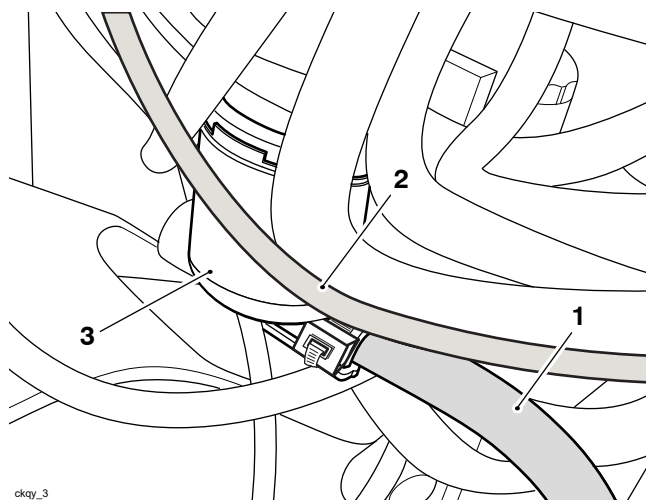
Internal investigations have identified that the front brake hose, if incorrectly routed, can cause damage to the ignition switch subharness wiring.

1. Check that the ignition switch subharness is routed below the front brake hose and is undamaged.

1. Ignition switch subharness
2. Front brake hose
3. Ignition switch

2. If correctly routed and undamaged, no further action is required. Complete check only warranty claim.
3. If incorrectly routed, refer to Ignition Switch Subharness - Inspect, Fit Conduit and Reroute”

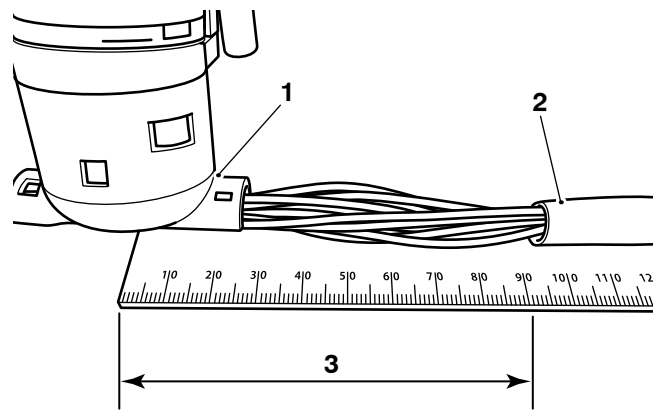
13. Trim the PVC tube to expose at least 90mm of the wires as they exit the ignition switch body.

14. Examine the exposed wiring for damage. If damage is observed undertake appropriate repairs or contact Triumph for further instruction

1. Ignition switch body
2. PVC tube
3. 90mm (exposed wires)

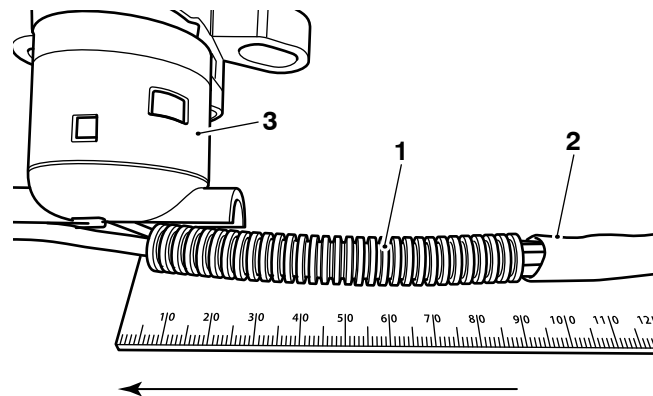
- The conduit must not overlap the PVC tube.
 - If the conduit overlaps the PVC tube trim the PVC tube to the required length.
15. Fit the the conduit over the exposed wires, do not allow the conduit to overlap the trimmed PVC tube.

1. Conduit
2. PVC tube
3. Ignition switch

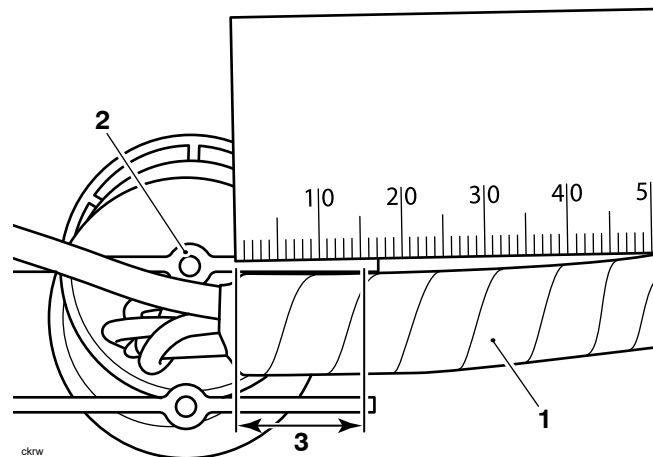
19. Position the conduit so that it overlaps the plastic body of the ignition lock by at least 15mm.

1. Conduit
2. Ignition switch
3. Overlap (15mm)

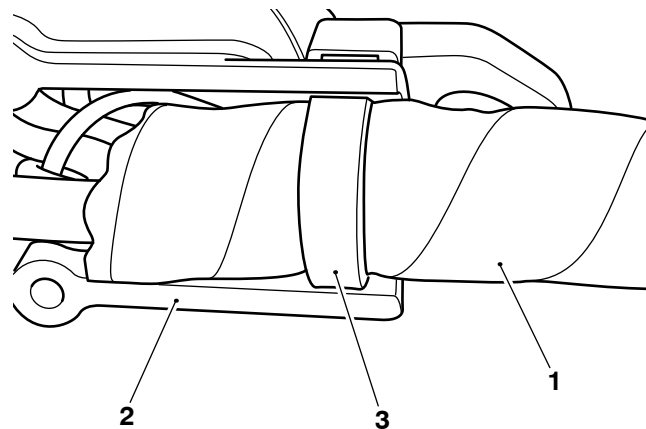
20. Pass a cable tie through the two holes, then tighten and trim the cable tie.

1. Conduit (wrapped in insulating tape)
2. Ignition lock body stem
3. Cable tie

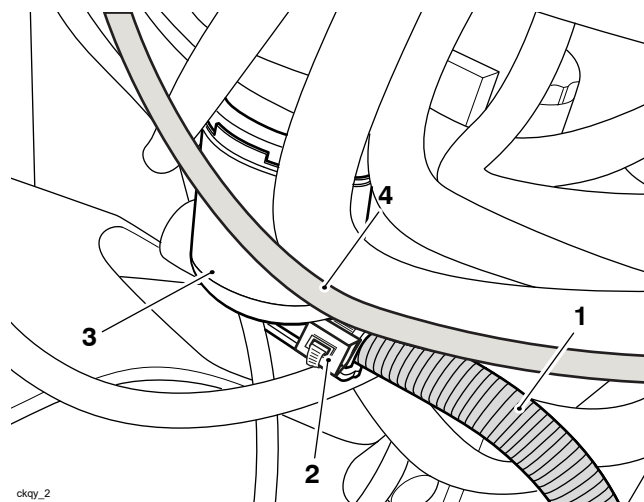
23. Route the switch housing subharness to the left hand side of the motorcycle. Make sure it is routed below the front brake hose.

1. **Ignition switch subharness**
2. **Cable tie**
3. **Ignition switch**
4. **Front brake hose**
