TECHNICAL INSTRUCTIONS FOR SAFETY RECALL 20TA06 POTENTIAL VEHICLE STALL WHILE DRIVING CERTAIN 2020 MODEL YEAR HIGHLANDER

UPDATE 3/26/2020

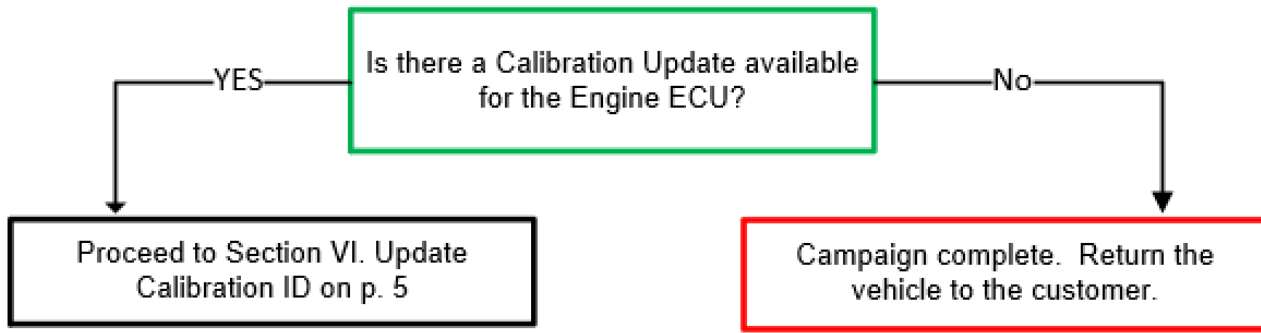
- Locate the Update column for the Engine ECU in the Stored Data tab.
- Determine the status of an available update; indicated by a YES or NO.

Campaign Status: **Yes**
PERMANENT: **NO**

System	SB	RoB	Calibration	Update
Radar Cruise2	-	-	-	-
Engine	-	-	896630735000	Yes
Transmission	-	-	896650706000	Yes
Radar Cruise1	-	-	-	-
Parking Assist Camera	-	-	867B02D167	No
	-	-	867B12D004	No
ABS/VSC/TRAC/EPB	-	-	F152607140	No
EMPS	-	-	8965B41080	No

Note: If the Engine ECU already has the updated Calibration ID, the campaign is complete. No further action is required. Submit the warranty claim using op code FB0001 to complete this vehicle.

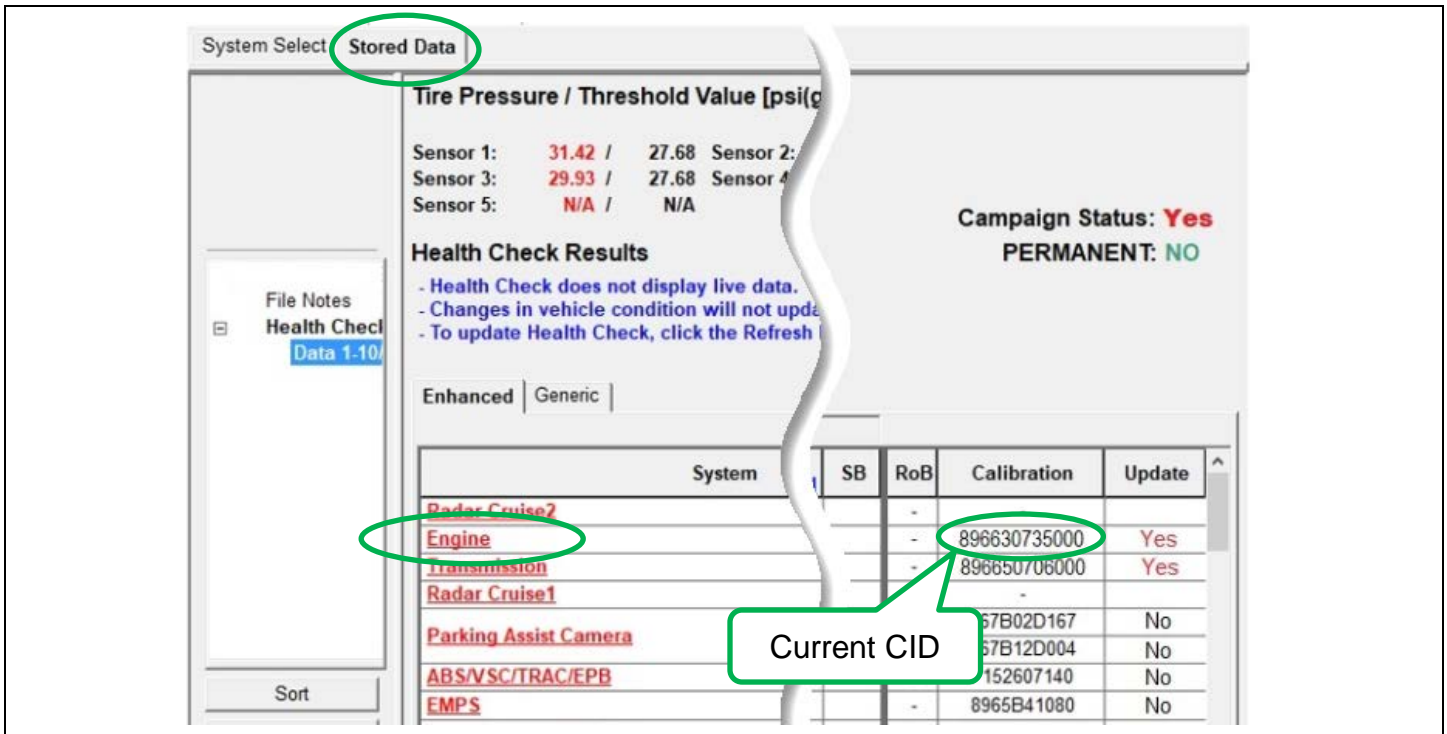
a. Identify the current Calibration ID for the Engine ECU on the Stored Data tab.

System	SB	RoB	Calibration	Update
Engine	-	-	896630735000	Yes
Transmission	-	-	896650708000	Yes
Radar Cruise1	-	-	-	-
Parking Assist Camera	-	-	57B02D167	No
ABS/VSC/TRAC/EPB	-	-	57B12D004	No
EMPS	-	-	152607140	No
	-	-	8965B41080	No

b. Locate the vehicles Current CID in the chart below.

c. Select the corresponding NEW CID link to load the update.

d. Follow the on-screen instructions to complete the ECU re-flash procedure.

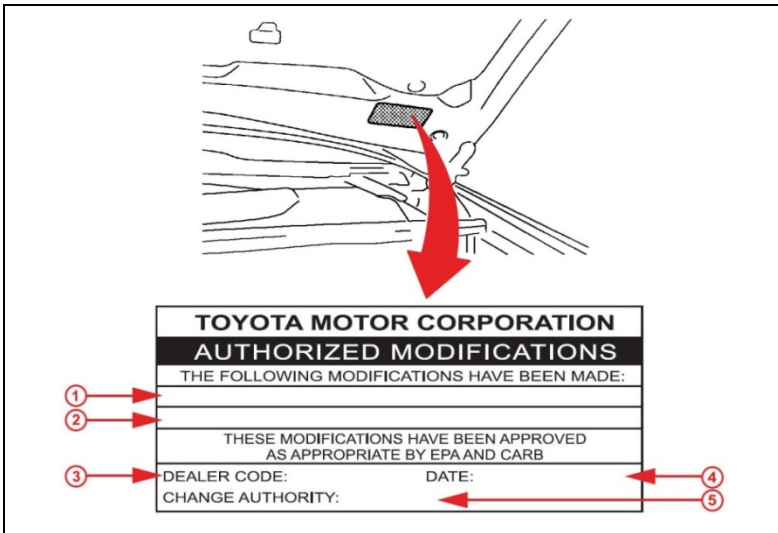
1	ECM P/N
2	New Calibration ID
3	Dealer Code
4	Date Completed
5	Campaign Code (20TA06)

6. ATTACH THE AUTHORIZED VEHICLE MODIFICATION LABEL

- a. Fill out the label.
- b. Affix the label to the under-side of the hood.
