Mercedes-Benz

Campaign No. 2020060013, July 2020

SUBJECT: **Model GLE-Class (167 platform)**
Model Year 2020
Welding of Rear Crossmember / Phase 1

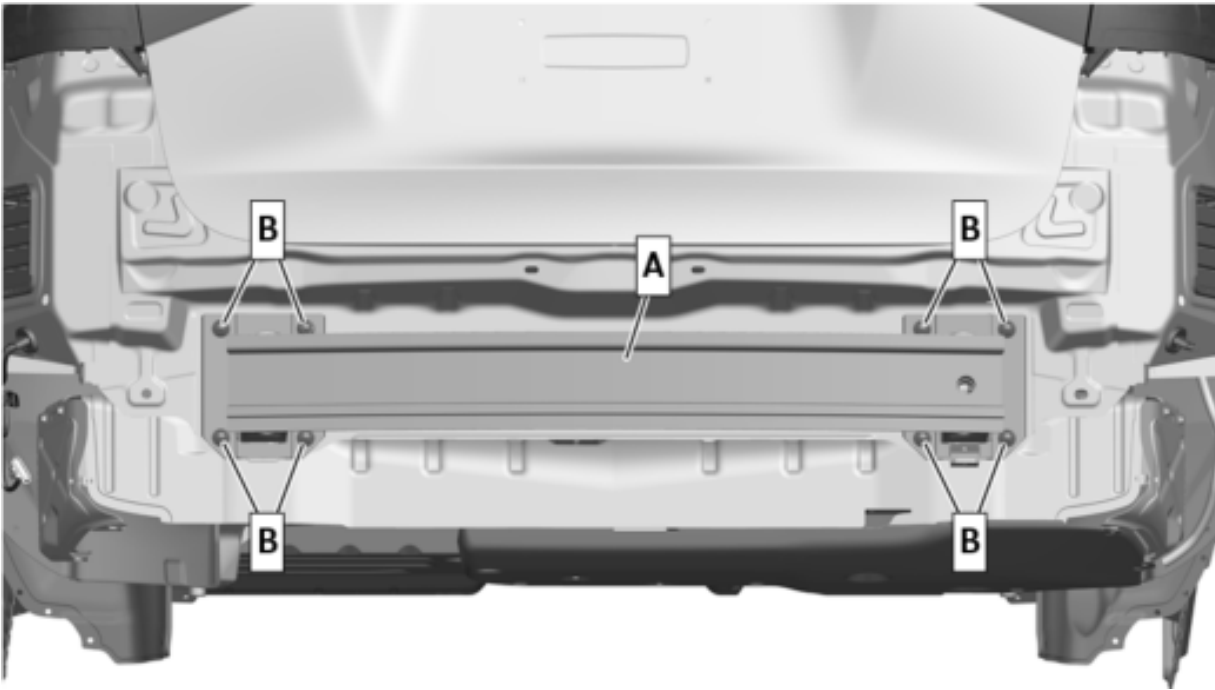
Figure 1

Mercedes-Benz AG, ("MBAG"), the manufacturer of Mercedes-Benz vehicles, has determined that on certain Model Year ("MY") 2020 GLE-Class (167 platform) vehicles, the tensile strength of the welds on the rear crossmember might not meet current production specifications. When the rear towing eye is used for towing, cracks might occur in the weld seams which could lead to the rear crossmember detaching from the vehicle, increasing the risk of a crash for other road users. An authorized Mercedes-Benz dealer will replace the rear crossmember on the affected vehicles.

1. Replace crossmember (A, figure 1) for rear bumper (AR88.20-P-2250ME).

i Replace nuts (B, figure 1).
