SIB 27 01 20

RECALL 20V-185: REPLACING THE FLEX DISC AND INSPECTING THE TRANSFER CASE

F30 (3 Series Sedan)	F31 (3 Series Sports Wagon)	With xDrive and N47T diesel engine
----------------------	-----------------------------	------------------------------------

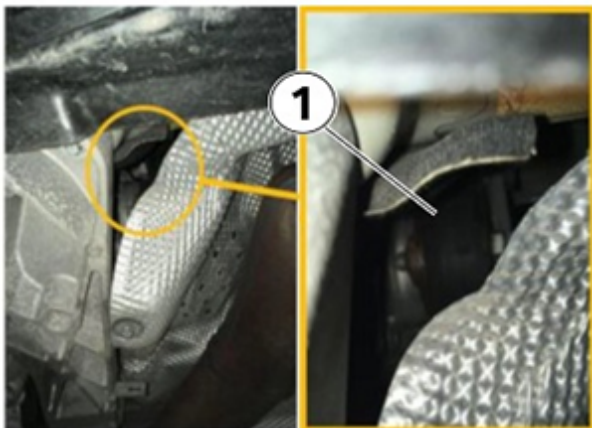
1. Raise the vehicle and determine which style flex disc is installed (1).

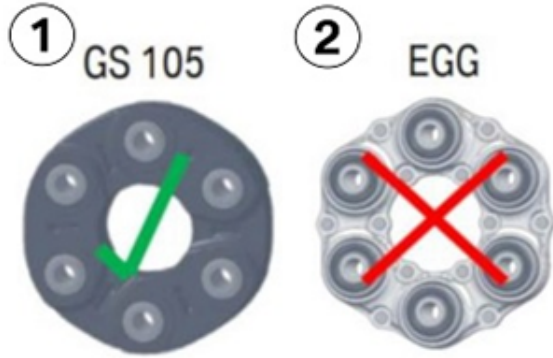
No further action is required if a black, corded rubber style (GS105) flex disc is installed (1).

If an aluminum style "EGG" (2) is installed, it **must** be replaced with a "GS 105" (1).

The transfer box output flange must then also be inspected for friction rust.

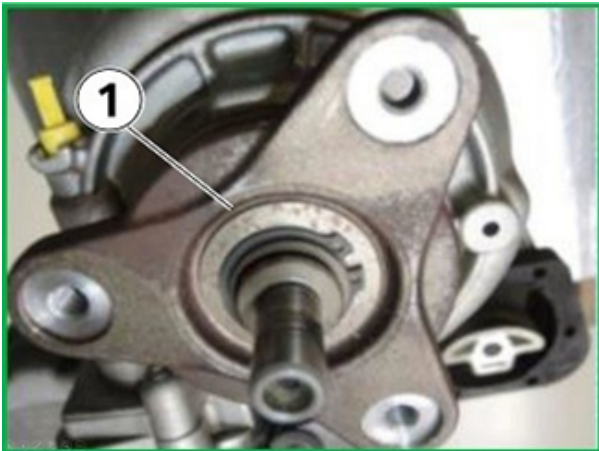
Typical output flanges without friction rust build up (1).

No further repair is necessary if there is no friction rust around the splines of the output flange.

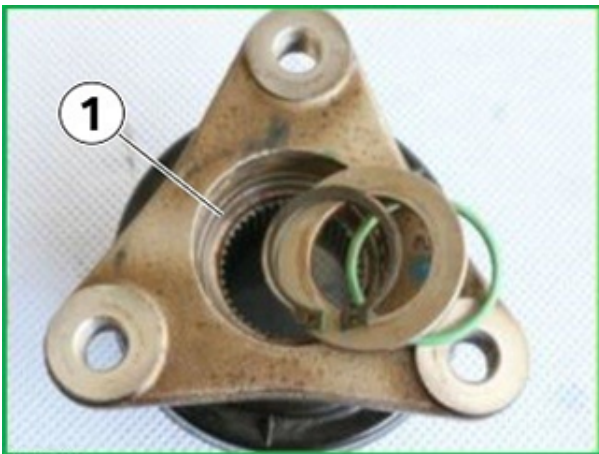
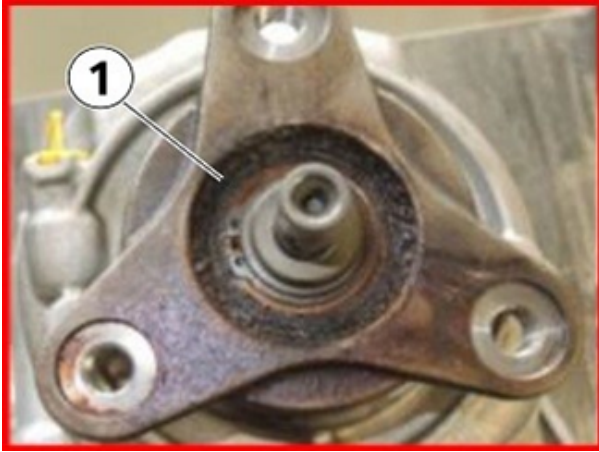
Output flanges with friction rust (1). Flanges with excessive friction rust will require transfer case replacement.

If rust build up cannot be determined by visual inspection, the flange will need to be removed for further diagnosis.

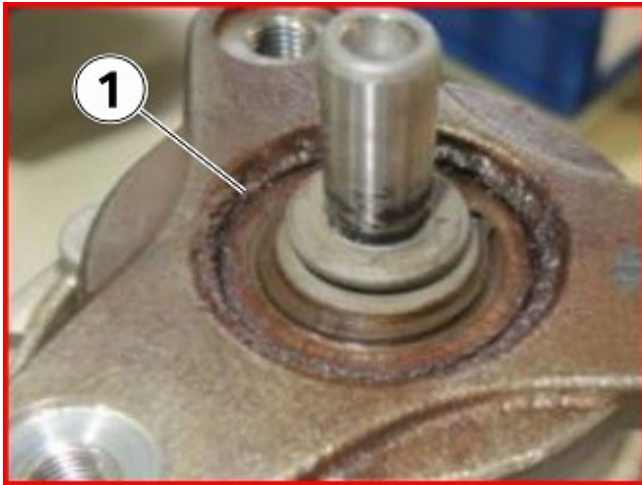
3. Check the flange for excessive play between the splines of the flange and the output shaft of the transfer case. No further dismantling of the flange is required if there is excessive play in the flange. Refer to the attached videos for reference (**V27 01 20 Acceptable Play in Transfer Case Flange** and **V27 02 20 Unacceptable Play in Transfer Case Flange**).

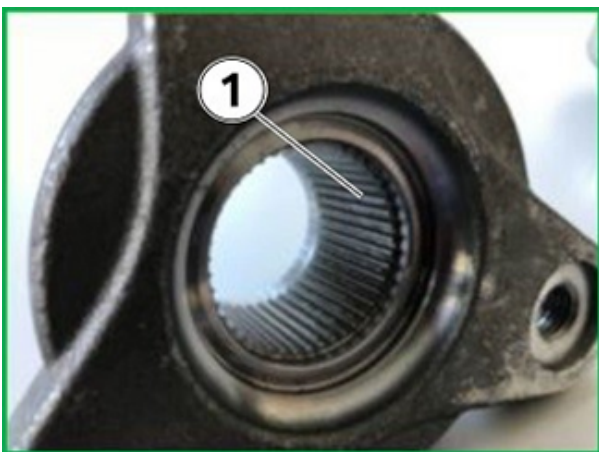
Inspect the splines on both the output flange and the transfer case output shaft (1).

Typical flange and output shaft **without** any friction rust damage (1). Reinstall the flange (with new radial oil seal, O-ring and retaining ring) and reassemble the vehicle with new flex disc.

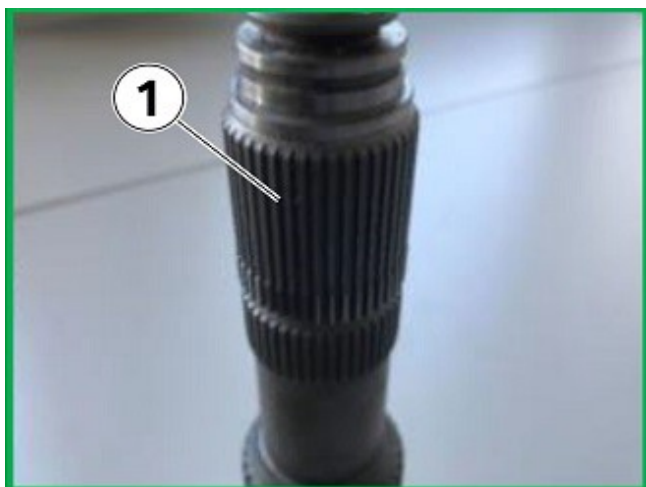
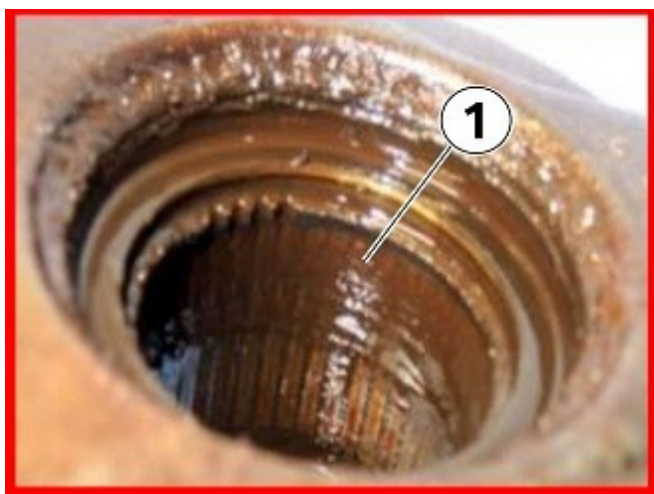
Flange and output shaft **with** friction rust damage (1). The transfer case will need to be replaced (with new flex disc).

NOTE: The transfer case needs to be replaced if either the flange or the output shaft are worn.

Follow Repair Instruction **27 10 020 Installing exchange transfer box (ATC 35L)**.
