SIB 27 01 20

RECALL 20V-185: REPLACING THE FLEX DISC AND INSPECTING THE TRANSFER CASE

F30 (3 Series Sedan)	F31 (3 Series Sports Wagon)	With xDrive and N47T diesel engine
----------------------	-----------------------------	------------------------------------

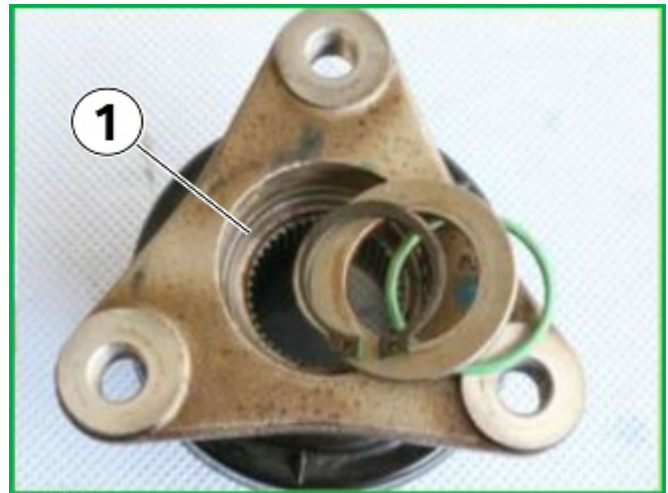
Typical output flanges without friction rust build up (1). No further repair is necessary if there is no friction rust around the splines of the output flange.

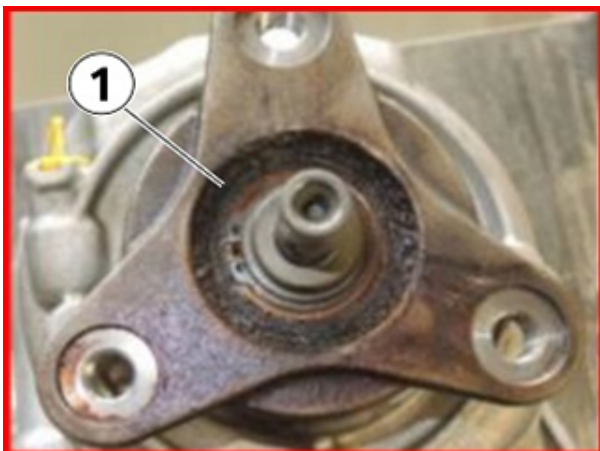
Higher dynamic load on the aluminum flex disc (EGG), which connects the transfer case to the rear driveshaft, can form friction rust on the output flange of the transfer case.

Output flanges with friction rust (1). Flanges with excessive friction rust will require transfer case replacement.

If rust build up cannot be determined by visual inspection, the flange will need to be removed for further diagnosis. Continue to Step 3.

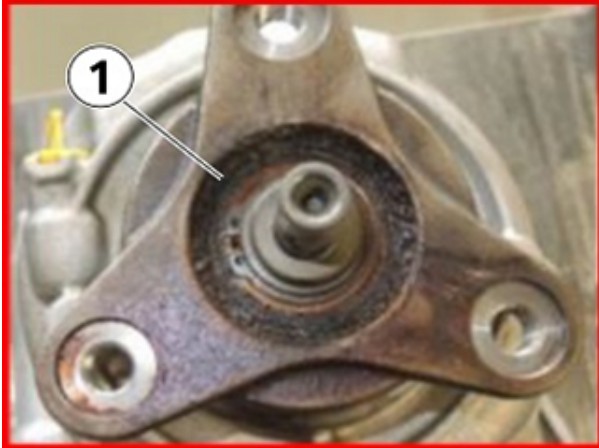
Typical flange and output shaft **without** any friction rust damage (1). Reinstall the flange (with new radial oil seal, O-ring and retaining ring) and reassemble the vehicle with new flex disc.

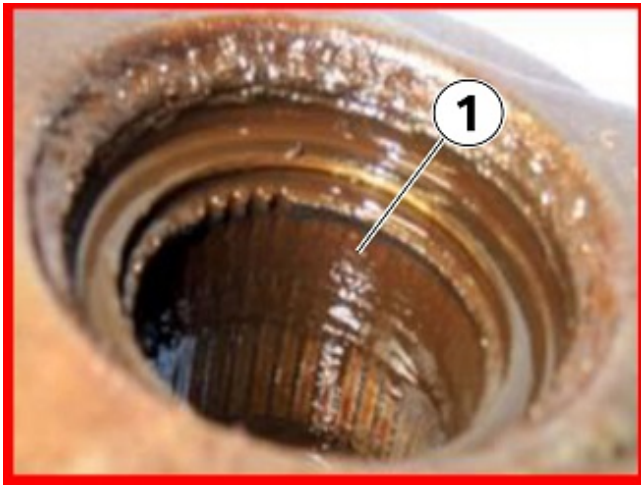
Flange and output shaft **with** friction rust damage (1). The transfer case will need to be replaced (with new flex disc).

NOTE: The transfer case needs to be replaced if either the flange or the output shaft are worn. Photo documentation will also be required. Take a sharply focused and well lit digital photo of the worn parts and send, with the VIN, to transfercase_check@bmw.com.

Follow Repair Instruction **27 10 020 Installing exchange transfer box (ATC 35L)**.
