SIB 27 01 20

RECALL 20V-185: REPLACING THE FLEX DISC AND INSPECTING THE TRANSFER CASE

F30 (3 Series Sedan)	F31 (3 Series Sports Wagon)	With xDrive and N47T diesel engine
----------------------	-----------------------------	------------------------------------

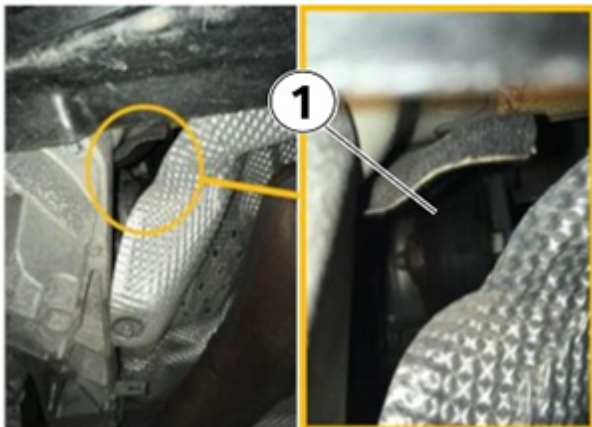
1. Raise the vehicle and determine which style flex disc is installed (1).

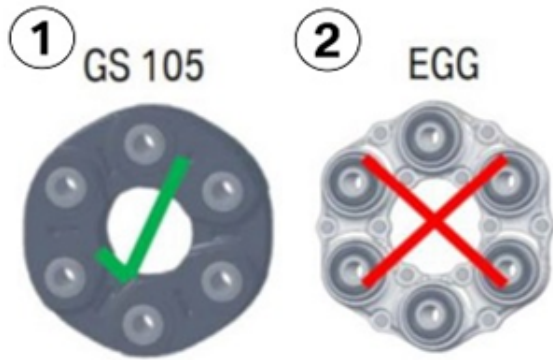
No further action is required if a black, corded rubber style (GS105) flex disc is installed (1).

If an aluminum style "**EGG**" (2) is installed, it **must** be replaced with a "**GS 105**" (1).

The transfer box output flange must then also be inspected for friction rust.

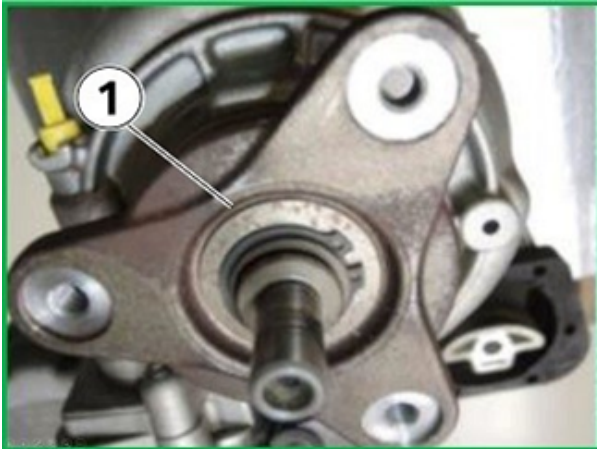
Typical output flanges without friction rust build up (1).

No further repair is necessary if there is no friction rust around the splines of the output flange.

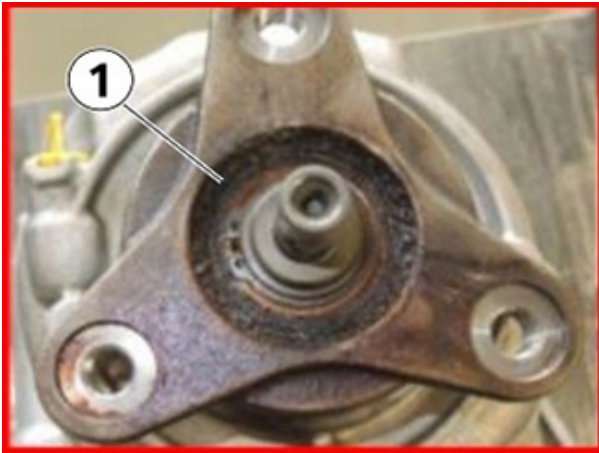
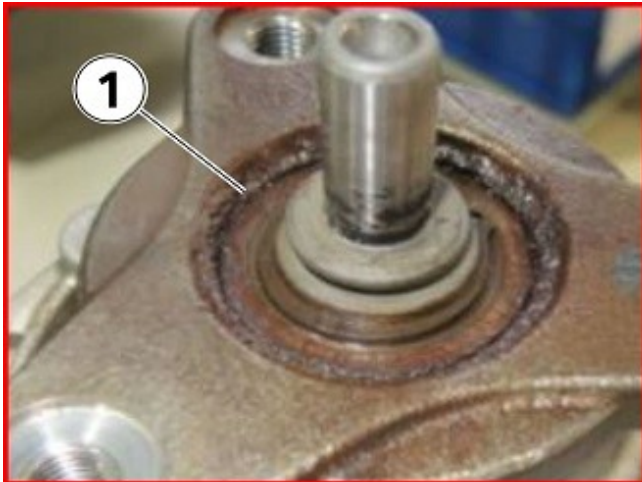
Higher dynamic load on the aluminum flex disc (EGG), which connects the transfer case to the rear driveshaft, can form friction rust on the output flange of the transfer case.

Output flanges with friction rust (1). Flanges with excessive friction rust will require transfer case replacement.

If rust build up cannot be determined by visual inspection, the flange will need to be removed for further diagnosis.

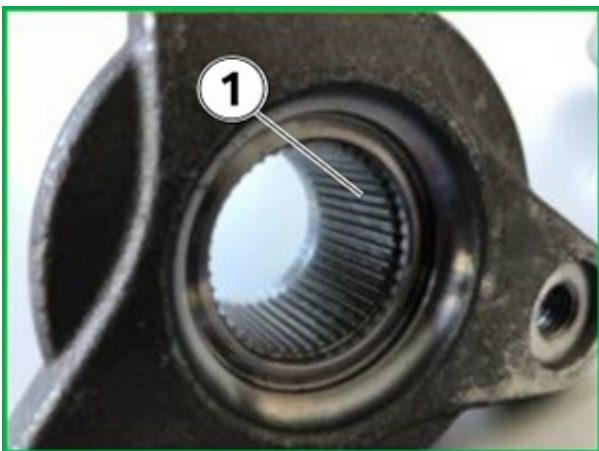
Typical flange and output shaft **without** any friction rust damage (1). Reinstall the flange (with new radial oil seal, O-ring and retaining ring) and reassemble the vehicle with new flex disc.
