SIB 27 01 20

**RECALL 20V-185: REPLACING THE FLEX DISC AND INSPECTING THE TRANSFER CASE**

F30 (3 Series Sedan)	F31 (3 Series Sports Wagon)	With xDrive and N47T diesel engine
----------------------	-----------------------------	------------------------------------

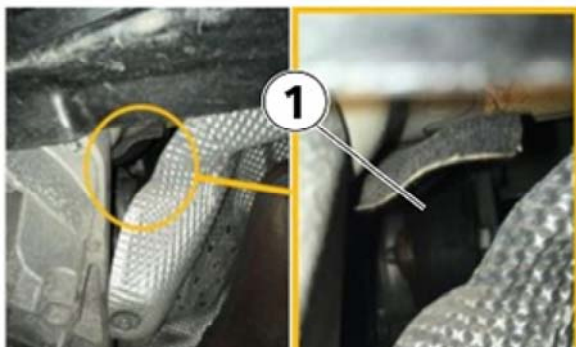
1. Raise the vehicle and determine which style flex disc is installed (1).

No further action is required if a black, corded rubber style (GS105) flex disc is installed (1).

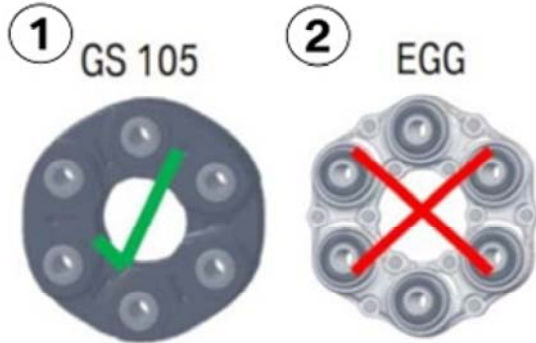
If an aluminum style (EGG) (2) is installed, it will **need** to be replaced and the output flange will need to be inspected.

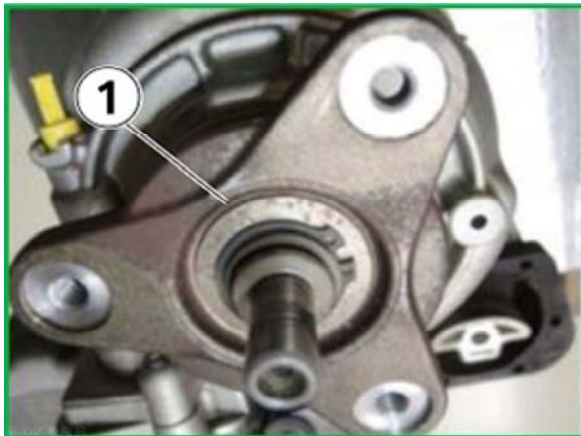
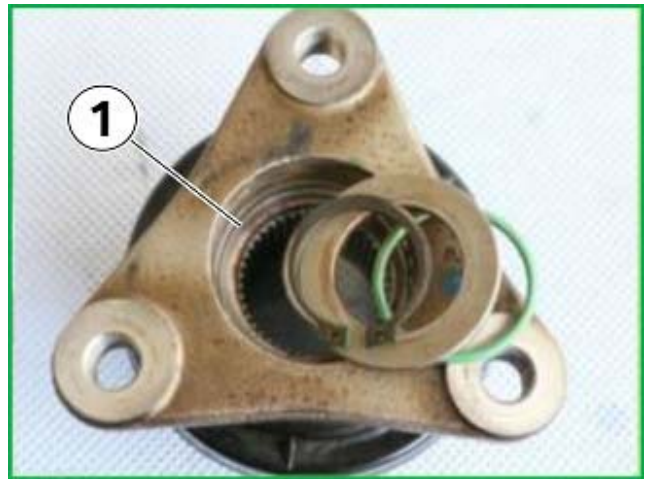
Typical output flanges without friction rust build up (1). No further repair is necessary if there is no friction rust around the splines of the output flange.

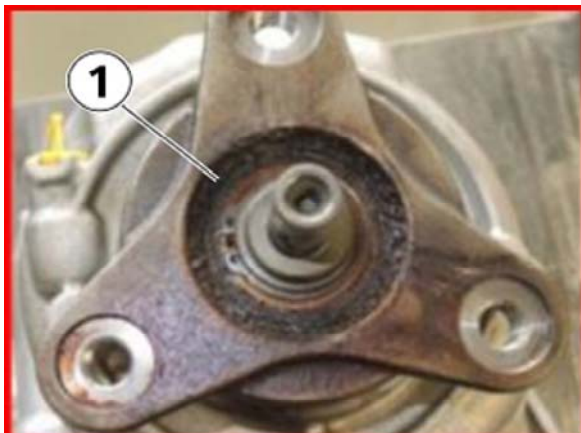
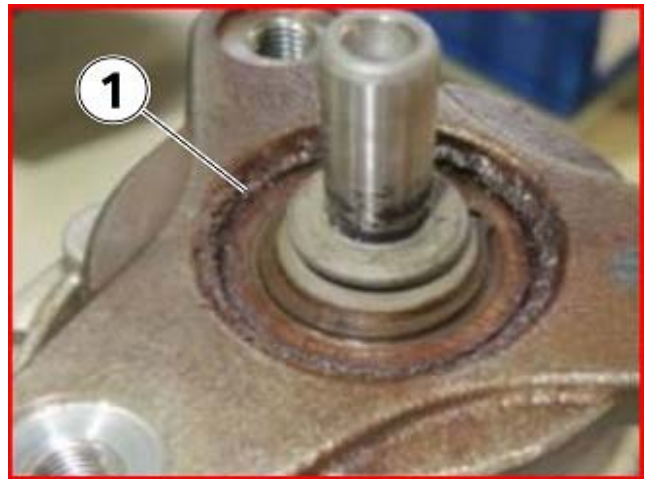
Output flanges with friction rust (1). Flanges with excessive friction rust will require transfer case replacement.

If rust build up cannot be determined by visual inspection, the flange will need to be removed for further diagnosis. Continue to Step 3.

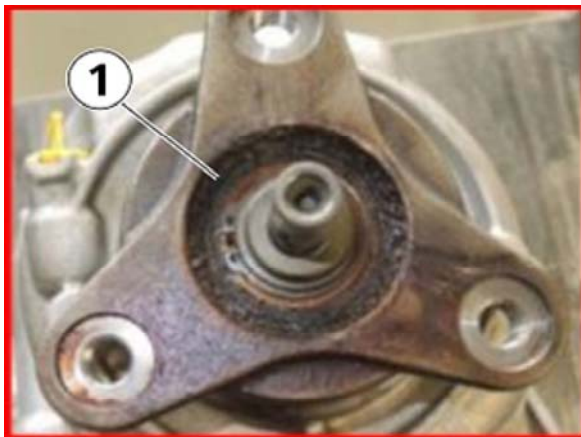
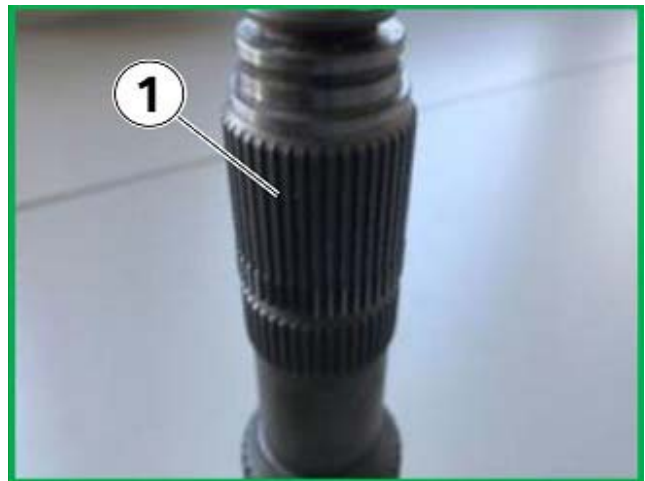
Typical flange and output shaft **without** any friction rust damage (1). Reinstall the flange (with new radial oil seal, O-ring and retaining ring) and reassemble the vehicle with new flex disc.

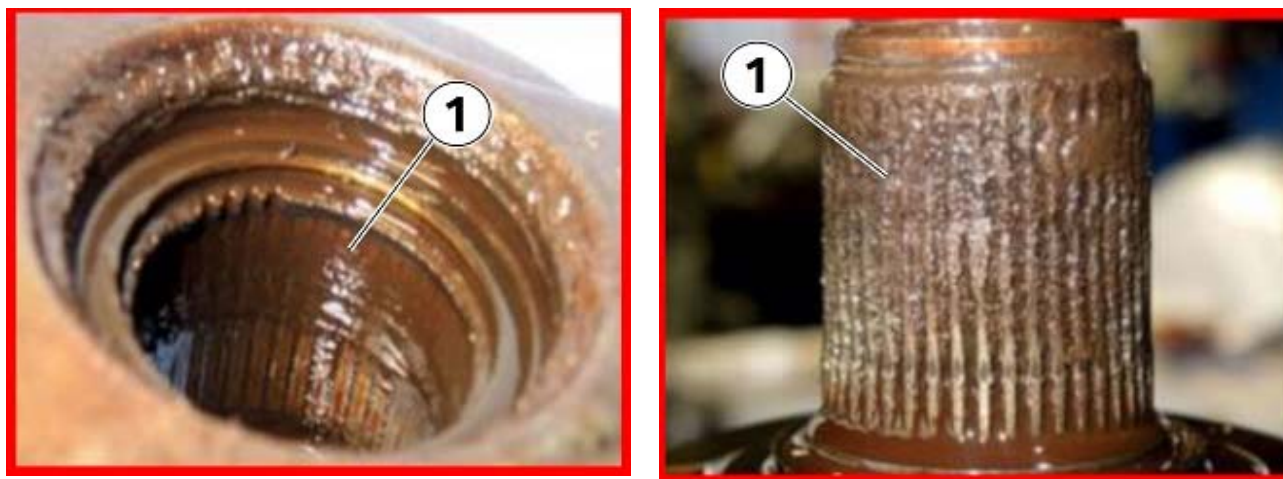
Flange and output shaft **with** friction rust damage (1). The transfer case will need to be replaced (with new flex disc).

**NOTE:** The transfer case needs to be replaced if either the flange or the output shaft are worn. Photo documentation will also be required. Take a sharply focused and well lit digital photo of the worn parts and send, with the VIN, to [transercase\\_check@bmw.com](mailto:transercase_check@bmw.com).

Follow Repair Instruction **27 10 020 Installing exchange transfer box (ATC 35L)**.
