Revision 2 May 2020

Safety Recall W37 / NHTSA 20V-191 VP4 Radio Software

2019 - 2020 (RU) Chrysler Pacifica

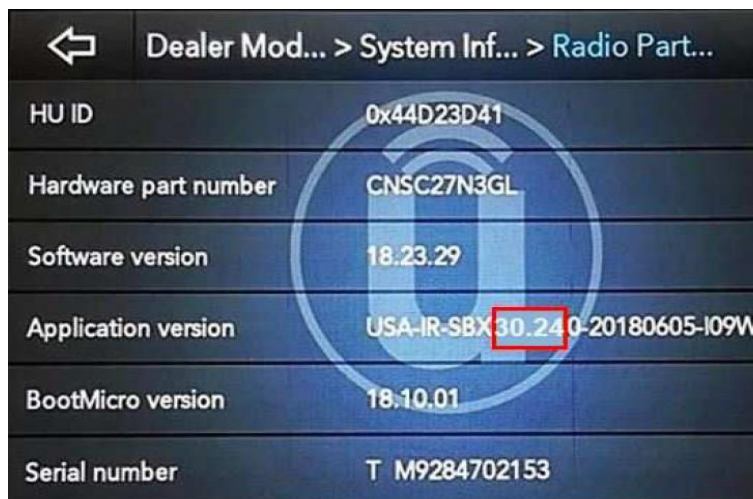
Figure 1 – Application Version Display

1. Turn the ignition to the “RUN” position.
2. Turn the radio to the “ON” position.
3. Press and hold the two lower corners of the radio display screen simultaneously until the “**Dealer Mode**” screen appears, approximately seven seconds, and then release the buttons.
4. Select “**Radio Part Information**”.
5. Is the radio “**Application Version**” **MR27.4, MR28.3, or MR28.32 for 8.4” radio and NR28.1, LR30.21, LR30.22, and LR33.3 for 12” radio?** (Figure 1).

➤ **NO** - The radio software is current. **No further action required.**

- **YES** - There is radio software update available. Please continue to section **B. Software Download**

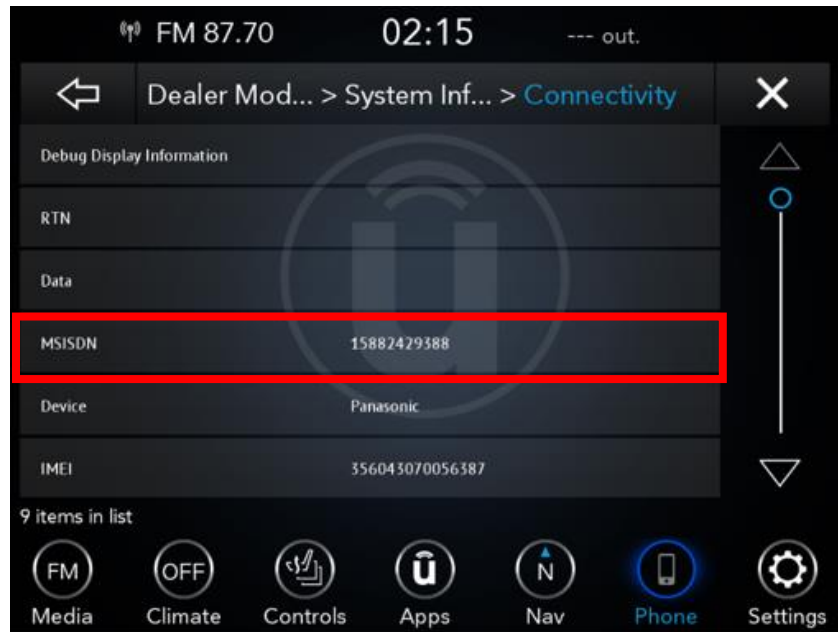
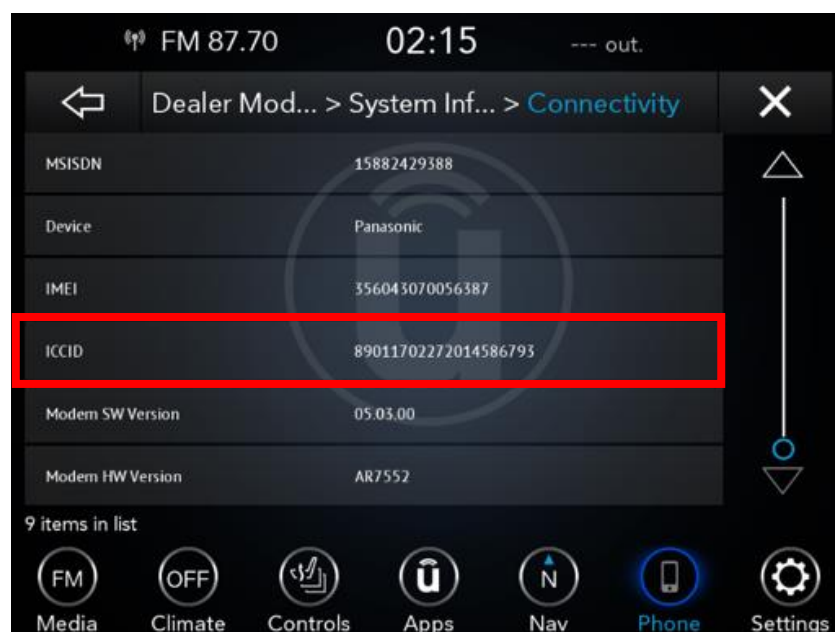
NOTE: Before software reflash, please enter the Dealer Mode ->Connectivity screen verify MSISDN and ICCID numbers. If those 2 fields are blank, do NOT proceed with the software reflash process, order a replacement. Replace radio under warranty, use Inspect LOP to close recall (Figure 2 and 3).

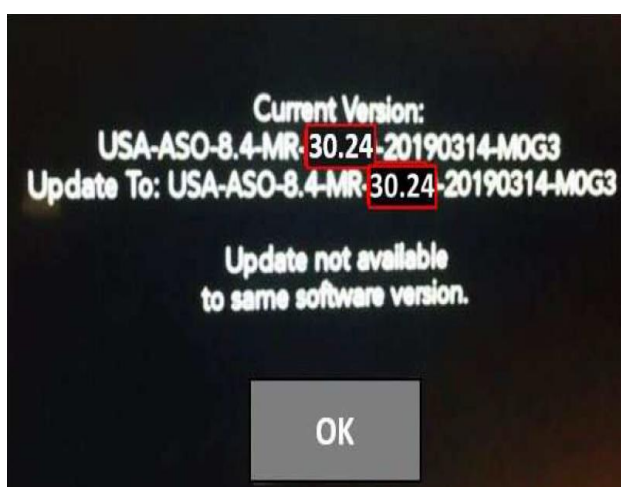
Figure 7 – Update Screen

2. Remove all devices (SD, USB, and AUX) from the media hub.
3. Insert the USB flash drive containing the downloaded software into the vehicle USB port.
4. Turn the ignition to the “ON” position.
5. Turn the radio to the “ON” position.
6. If the current version” and “Update To” are the same Press “OK” and remove the USB flash drive (Figure 7).

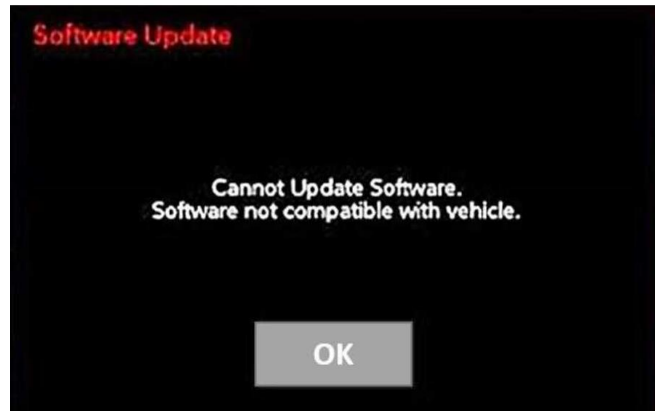
Figure 8 – Software Not Compatible

7. If the screen displays “**Cannot Update Software**” the USB flash drive was not set up correctly. Use a top name brand USB and create a new flash drive and start the update again (Figure 8).

NOTE: If you receive an Error 01 message, verify the USB was created properly. If error persists reformat the drive and begin again.

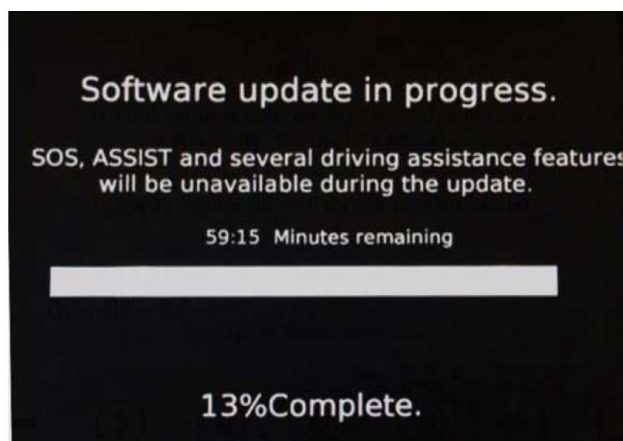
Figure 11 – Software Update Progress

10. The radio will reboot and the update will begin. The update should only take 20 minutes, the timer on the screen may display the incorrect time remaining (Figure 11).

Note: If the radio update fails along the way you may receive an Error message on the screen; DO NOT remove the USB at this time. The radio will roll back to the previous software level and attempt the radio update up to three times. Please allow up to 15 minutes for the rollback to occur before the update retries.

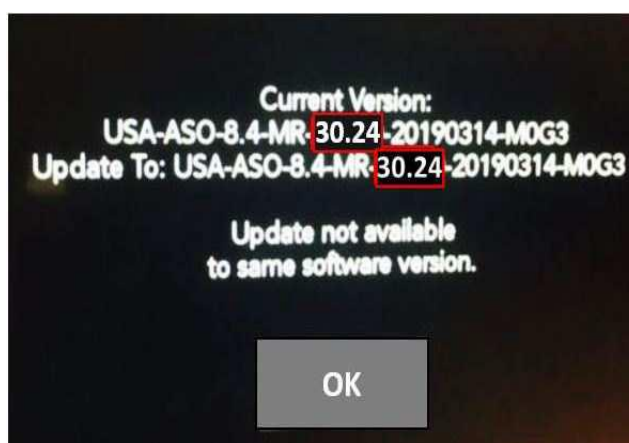
Figure 12 – Software Updated Screen

11. After the update has completed, the radio will shut down. With the USB flash drive still inserted in the USB port. If the radio has been updated correctly, the screen will be displayed. Press “OK” and remove the USB flash drive (Figure 12).

12. Start a wiTECH session and clear fault codes.
