Revision 1 May 2020

Safety Recall W36 / NHTSA 20V-191 VP4 Radio Software

2019 - 2020 (WK) Jeep® Grand Cherokee

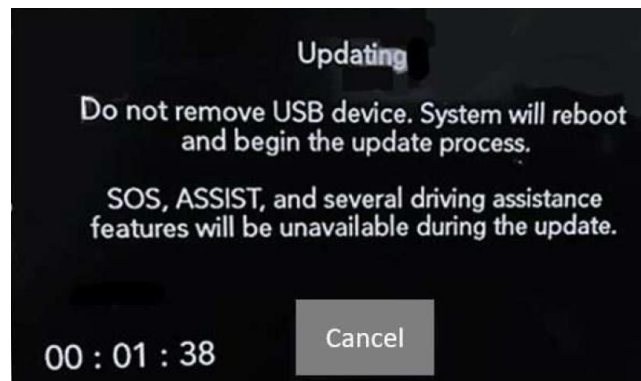
**Figure 7 – Updating Screen**

9. Updating screen will be displayed (Figure 7).
