April 2020

Dealer Service Instructions for:

## **Safety Recall W34 / NHTSA 20V-191 VP4 Radio Software**

### **2020 (KL) Jeep Cherokee**

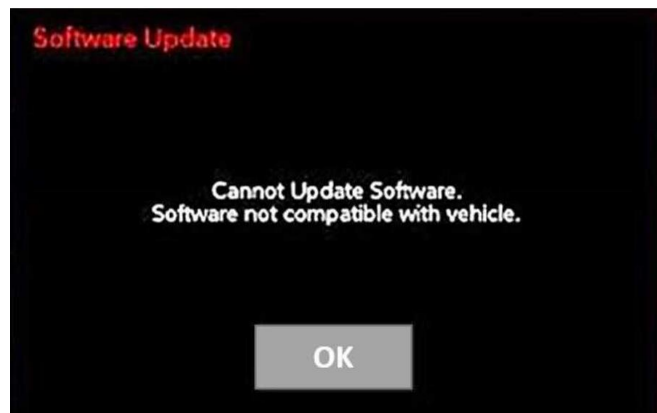
**Figure 5 – Software Not Compatible**

7. If the screen displays “**Cannot Update Software**” the USB flash drive was not set up correctly. Use a top name brand USB and create a new flash drive and start the update again.  
(Figure 5)

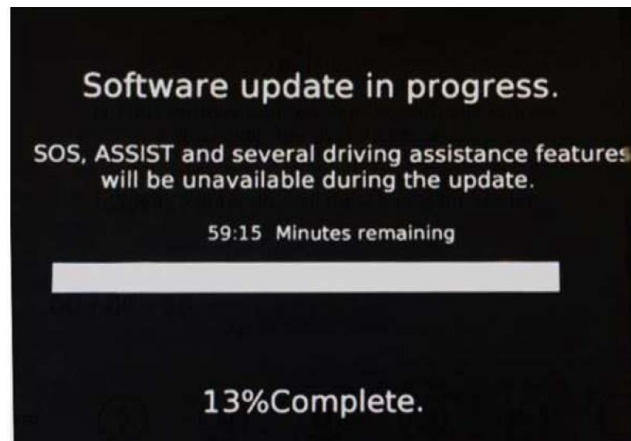
**Figure 8 – Software Update Progress**

10. The radio will reboot and the update will begin. The update should only take 20 minutes, the timer on the screen may display the incorrect time remaining (Figure 8).

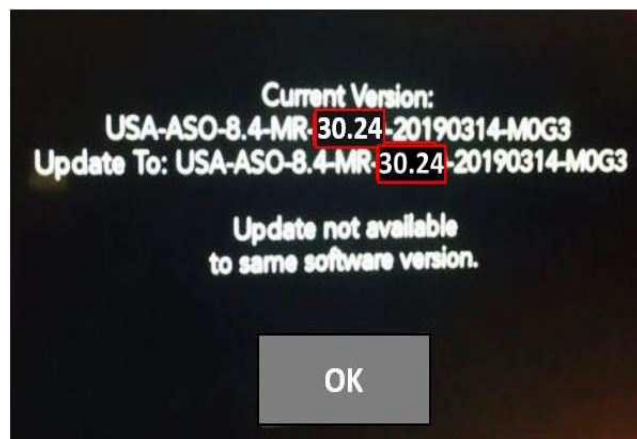
**Figure 9 – Software Updated Screen**

11. After the update has completed, the radio will shut down. With the USB flash drive still inserted in the USB port. If the radio has been updated correctly, the screen will be displayed. Press “OK” and remove the USB flash drive (Figure 9).
