Revision 1 April 2020

Dealer Service Instructions for:

Safety Recall W32 / NHTSA 20V-191 VP4 Radio Software

Remedy Available

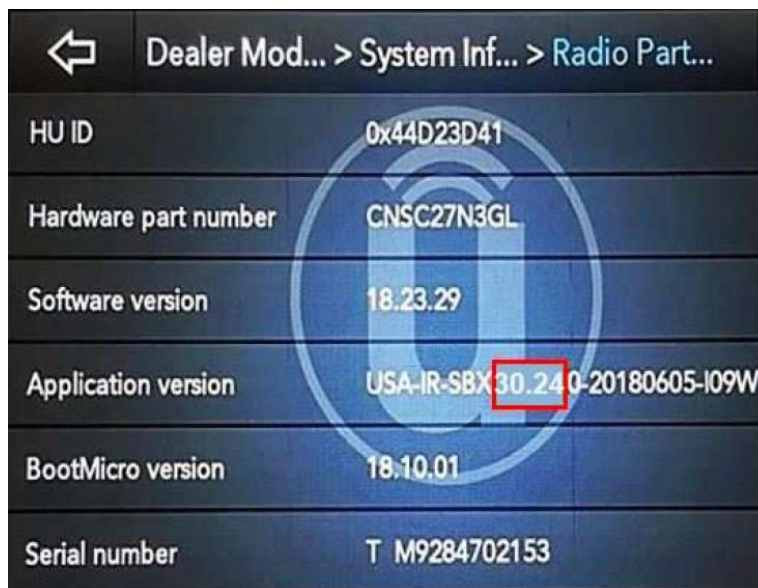
Figure 1 – Application Version Display

1. Turn the ignition to the “RUN” position.
2. Turn the radio to the “ON” position.
3. Press and hold the two lower corners of the radio display screen simultaneously until the “**Dealer Mode**” screen appears, approximately seven seconds, and then release the buttons.
4. Select “**Radio Part Information**”.
5. Is the radio “**Application Version**” **JR33.3** or higher? (Figure 1).
 - **Yes** - The radio software is current. **No further action required.**
 - **No** - **There is** radio software update available. Please continue to section **B. Software Download**

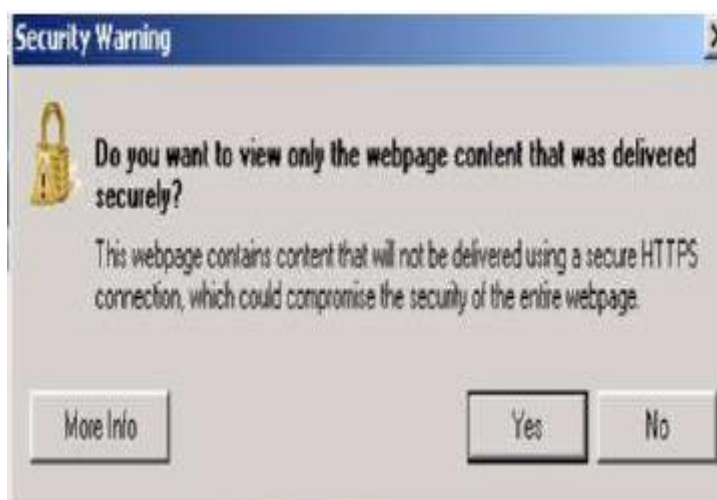
Figure 2 – Security Warning

NOTE: If a security message appears ‘Do you want to view only the web page content that was delivered securely?’ select “NO” and continue (Figure 2).

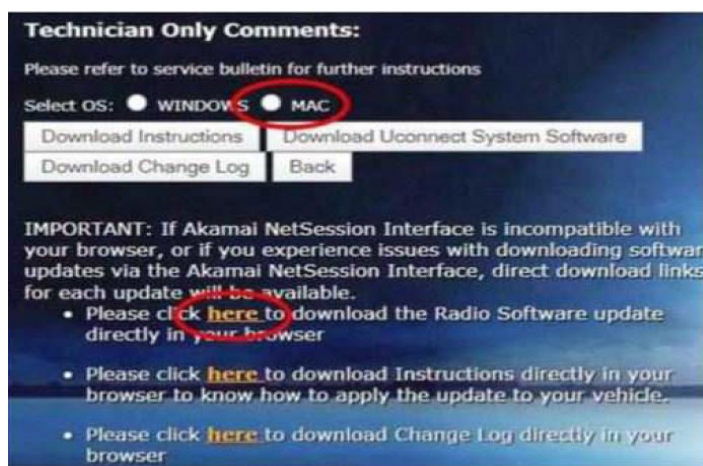
Figure 3 – Operating System Selection

10. Enter the VIN into Dealer Update ePortal and select “Go”.
11. Select Software Release ID.
12. Select the “MAC” operating system (OS) only (Figure 3).

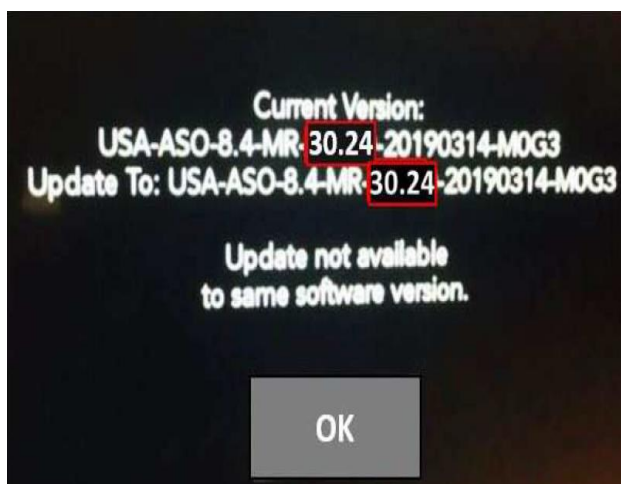
Figure 4 – Update Screen

2. Remove all devices (SD, USB, and AUX) from the media hub.
3. Insert the USB flash drive containing the downloaded software into the vehicle USB port.
4. Turn the ignition to the “ON” position.
5. Turn the radio to the “ON” position.
6. If the current version” and “Update To” are the same Press “OK” and remove the USB flash drive (Figure 4).

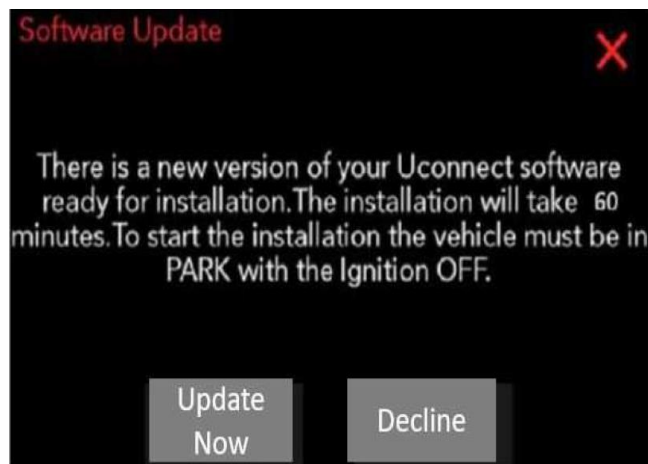
**Figure 6 – Software Selection**

8. Select the ‘**Update Now**’ button (Figure 6).
