Revision 1 May 2020

Dealer Service Instructions for:

Safety Recall W37 / NHTSA 20V-191 VP4 Radio Software

2019 - 2020 (RU) Chrysler Pacifica

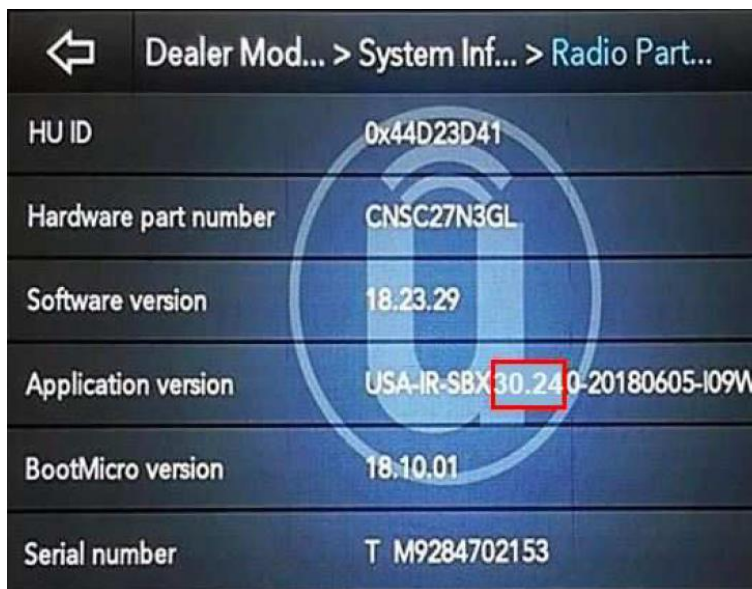
Figure 1 – Application Version Display

1. Turn the ignition to the “RUN” position.
2. Turn the radio to the “ON” position.
3. Press and hold the two lower corners of the radio display screen simultaneously until the “**Dealer Mode**” screen appears, approximately seven seconds, and then release the buttons.
4. Select “**Radio Part Information**”.
5. Is the radio “**Application Version**” **IR22.6** or lower or **JR30.24** or higher? (Figure 1).
 - **Yes** - The radio software is current. **No further action required.**

- **No** - There is radio software update available. Please continue to section **B. Software Download**

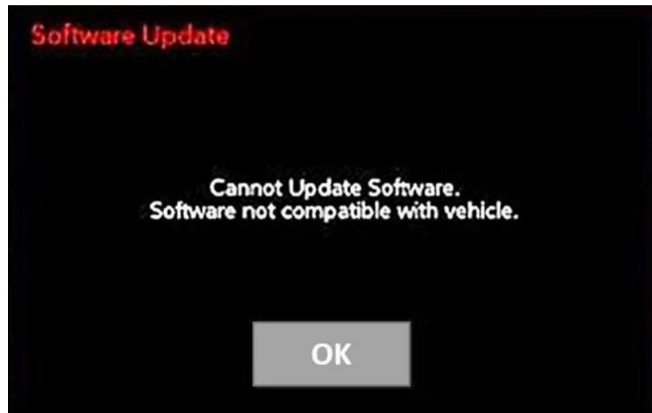
Figure 5 – Software Not Compatible

- If the screen displays “**Cannot Update Software**” the USB flash drive was not set up correctly. Use a top name brand USB and create a new flash drive and start the update again (Figure 5).
