Product Safety Recall

N202303140 Brake Line Routing

Release Date: May 2020

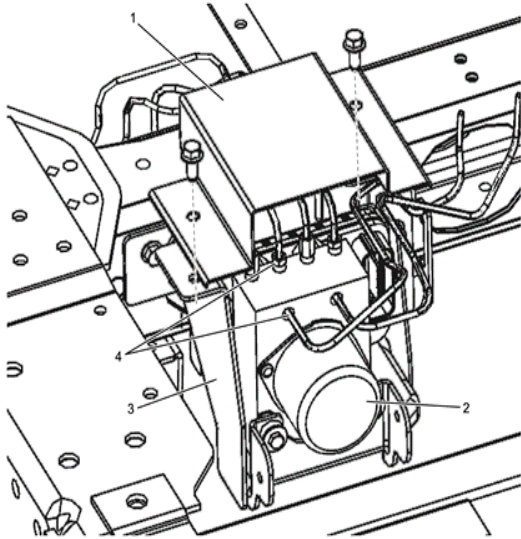
5587402

2. Inspect for the proper brake pipe clip placement on the inside of the Right Hand Frame Channel, directly above the Number 1 Oxygen Sensor Connector Bracket. If the pipe clip has been installed in the correct location (1), no further action required. If the pipe clip is installed in the incorrect location (2), with brake line to grounding bolt interference, proceed to Step 3.
3. Remove the front lower grille. Remove the ABS module cover.

Correction	Dealers will inspect the brake line mounting clips of affected vehicles in their inventory (if applicable) to determine if the brake line clip(s) were installed correctly per the inspection procedure provided in this bulletin. This service will be performed free of charge. If the clips are not installed correctly, the brake line will have to be replaced.

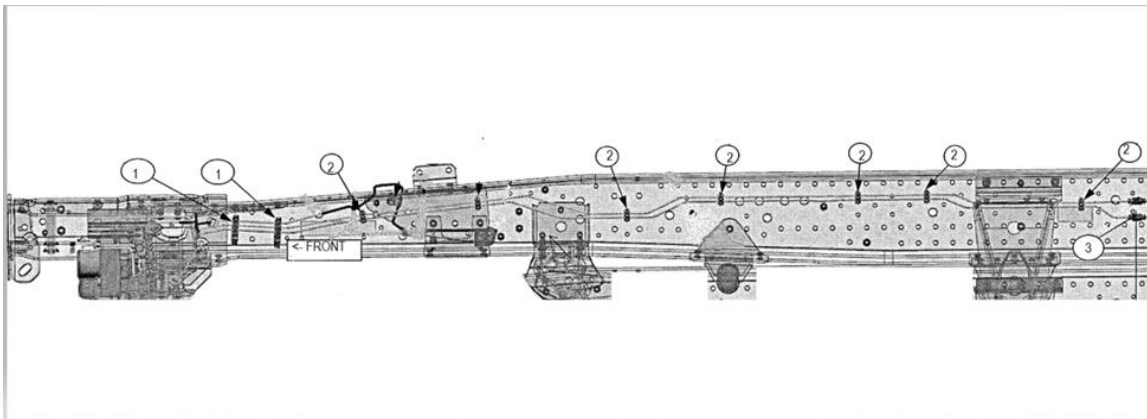
5587414

- (1) Large White Pipe Clip
- (2) Small Grey or Black Pipe Clip
- (3) Brake Pipe Union Joint

11. Make note of the proper type and locations for the 7 plastic clips securing the brake line. Use a paint pen or caulk to draw a circle around each clip hole on the outside of the frame. (See Figure 9.)
