Product Safety Recall

N202303150 Chassis Harness Improperly Routed

Release Date: May 2020

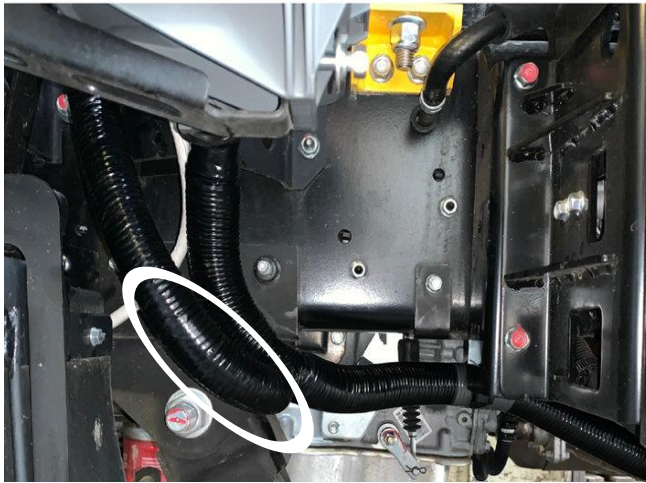
5600807

3. Inspect the Harness for contact with the Left Front, Rear Leaf Spring Hanger Bracket. Figure 1 indicates where the harness may contact the Bracket.
 - 3.1. If the harness is not contacting the spring hanger and/or there is no sign of harness damage continue to Step 4.
