BULLETIN NUMBER:
CB20-N-001

IMPORTANT SAFETY RECALL

HARNESS INSPECTION & CLIP INSTALLATION – V2003

- 2018-2020MY Isuzu FTR Vehicles Produced Between February 6, 2018 and February 5, 2020 (Canada Produced Between February 19, 2018 and December 4, 2019)

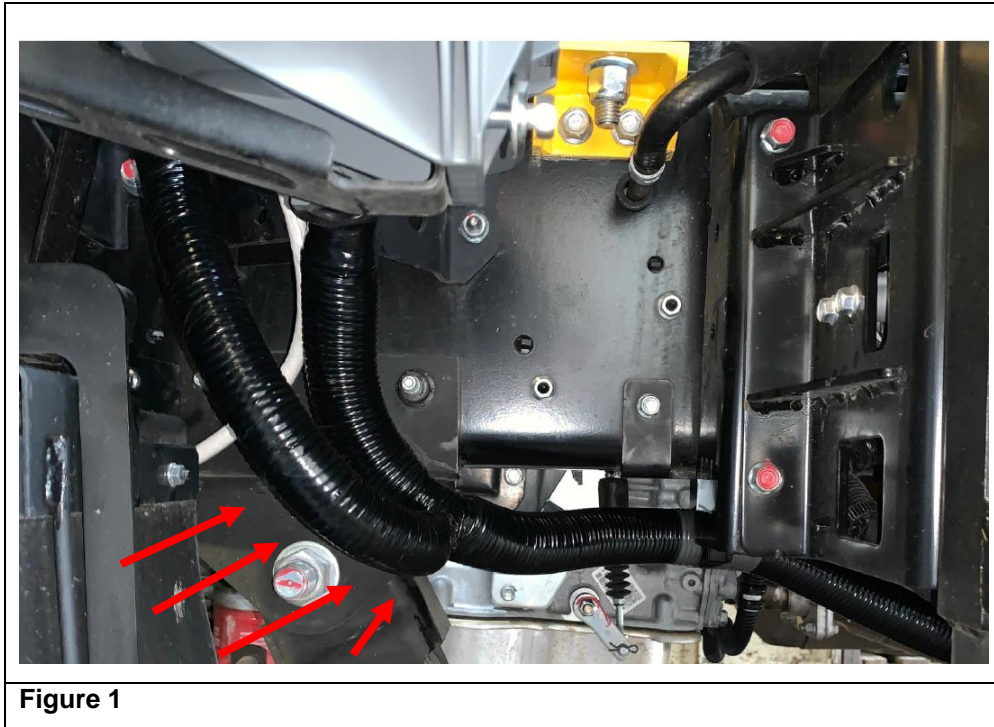
Figure 1

Isuzu Motors Limited has decided that a defect, which relates to motor vehicle safety, exists in certain 2018-2020MY Isuzu FTR vehicles produced between February 6, 2018 and February 5, 2020. In the affected vehicles, the chassis wire harness outside the relay box was improperly routed. As routed, it can contact the suspension's leaf spring hanger bracket, causing the harness to chafe and the wires to be damaged. Depending on which of the wires within the harness is affected, different systems could be impacted, yielding varying possible results including the possibility of a vehicle stall and/or reduced functionality of the ABS brake system. These results could increase the risk of a crash.

1. Place the vehicle in park, apply the parking brake, turn the engine off and block the rear tires.
2. Disconnect the negative (-) battery cable.
3. Inspect the Harness for contact with the Left Front Leaf Spring’s, Rear Hanger Bracket.

- a. If there is any damage to the harness or wires, take a photo of the damage and email it to isuzuta@icta-us.com. Then call the Isuzu Technical Assistance Line at 1-877-478-9828, Prompt 3 for further instructions. Document the TAL case number on the repair order. This will be required for claim submission. After the harness has been repaired or replaced per the instructions from the Isuzu Technical Assistance Line, continue to Step 4.
 - b. If the harness is not contacting the spring hanger and/or there is no sign of harness damage continue to Step 4.
4. Familiarize yourself with the parts of the Harness Hardware Kit shown in Figure 2.
