Mercedes-Benz

Campaign No. 2020050009, May 2020

SUBJECT: **Model GLE-Class (167 platform) vehicles**
Model Year 2020
Check Wiring Harness for Second Seat Row Right

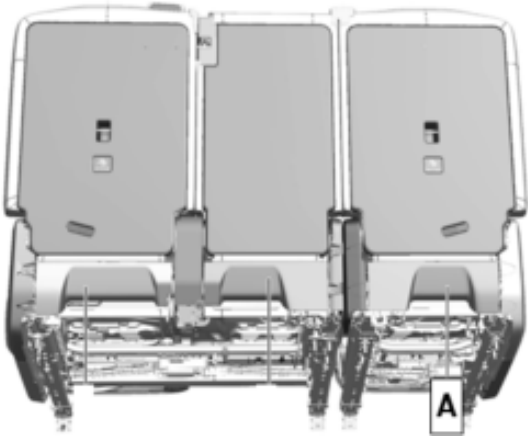
Figure 1

1. Remove the wiring harness cover (**A, figure 1**) of the right-hand second seat row (40% side).

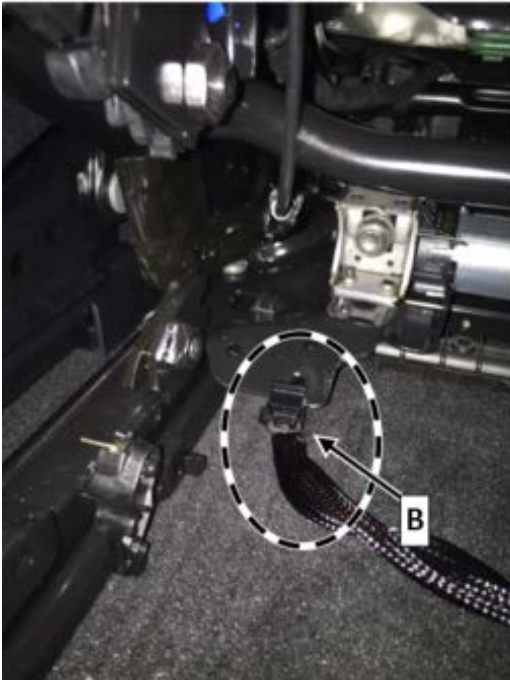
Figure 1 – OK

2. Check to see if the mounting clip for the wiring harness is positioned **correctly** on the holder (**B, figure 2**).

i (Figure 2) shows the **OK** condition.

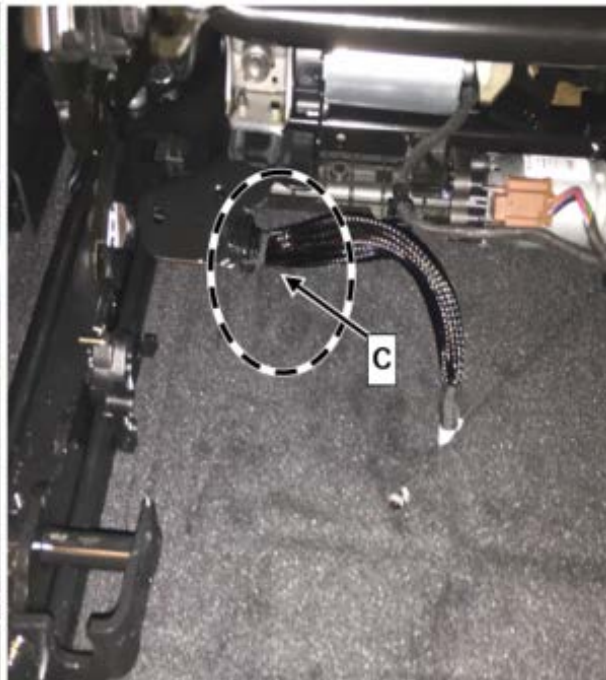
Figure 3 – NOT OK

i The mounting clip may be positioned incorrectly on the holder and was installed so that it is turned by 90° (**C, figure 3, not OK**).

The wiring harness must **not** be in contact with the guide rail.

- Cut through the cable strap for the mounting clip using a side cutting pliers.
i The protective sleeve and individual lines must not be damaged when doing this.
- Check the protective sleeve and the individual lines for damage.
i Repair the wiring harness and/or the protective sleeve if they have been damaged.
i Use fabric tape to repair the protective sleeve.
i Use a line connector to repair the wiring harness.
- Then use a new mounting clip to position the wiring harness correctly as shown in Figure 2.
- Assemble in reverse order.
