Subject: Front Brake Hose Rework			
Field Change Program: Field Campaign	FCP Number: 481	Revision: A	Date: 06/24/2020
Coach Section: 04-Brakes & Air system	P/N: 04-20-1817		Type: Safety Recall

Ref. NHTSA Recall No.: 20V-233	Ref. Transport Canada Recall No.: 2020-179
--	--

1.0 Description

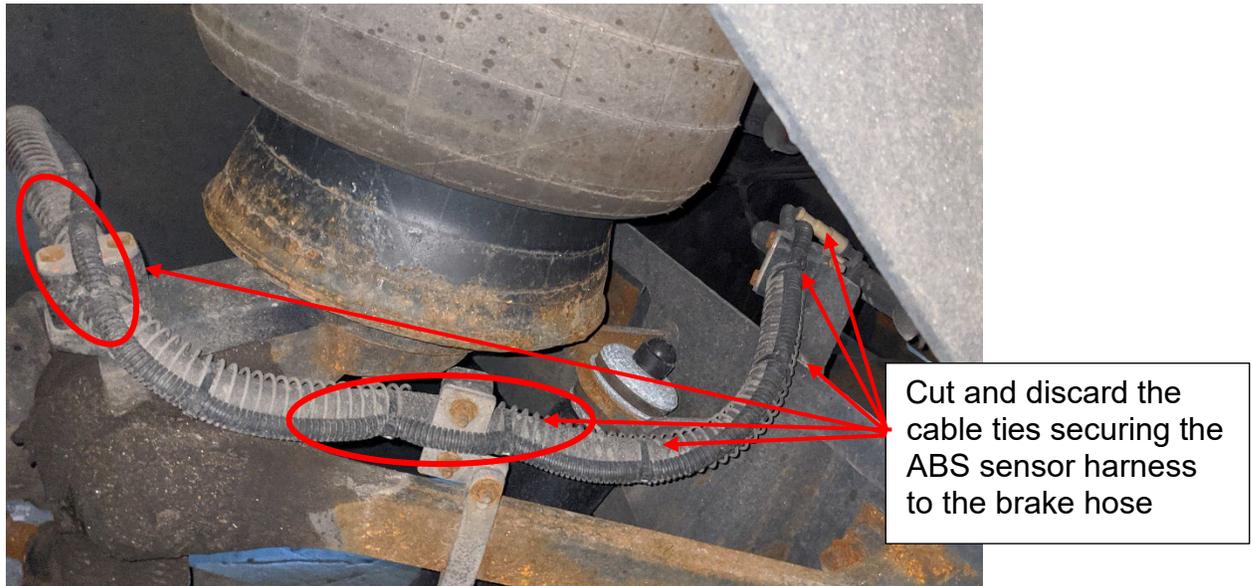
Drain air off the coach following instructions in the maintenance manual. Cut and discard the cable ties securing the ABS sensor harness to the front brake hose assembly on the driver side. Disconnect the front brake hose assembly from the ABS front module and front brake chamber on the wheel.

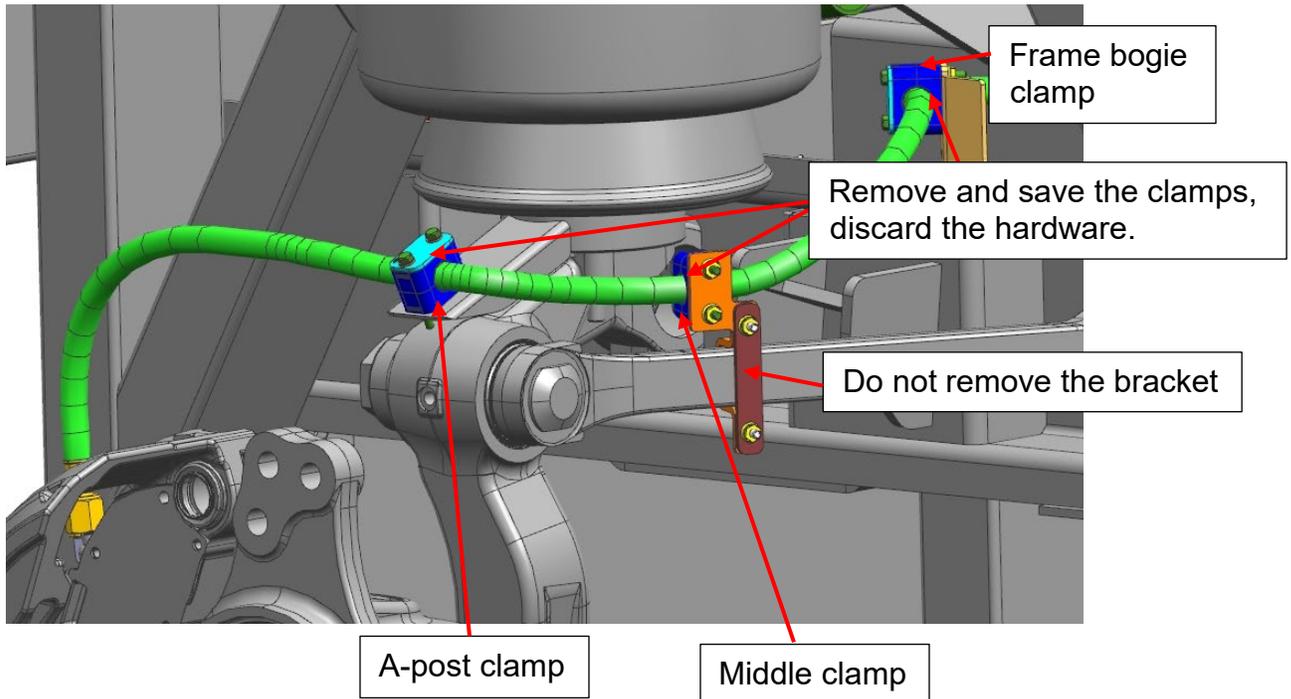
Remove the three clamps (A-post clamp, middle clamp, and frame bogie clamp), plates, and hardware securing the brake hose to the axle. Save the clamps and plates. Discard the hardware. Make sure not to remove the bracket securing the middle clamp.
