Mercedes-Benz

Campaign No. 2020070009, July 2020

SUBJECT: **Model GLB-Class vehicles (247 platform)**
Model Year 2020
Vehicle Body Sealing

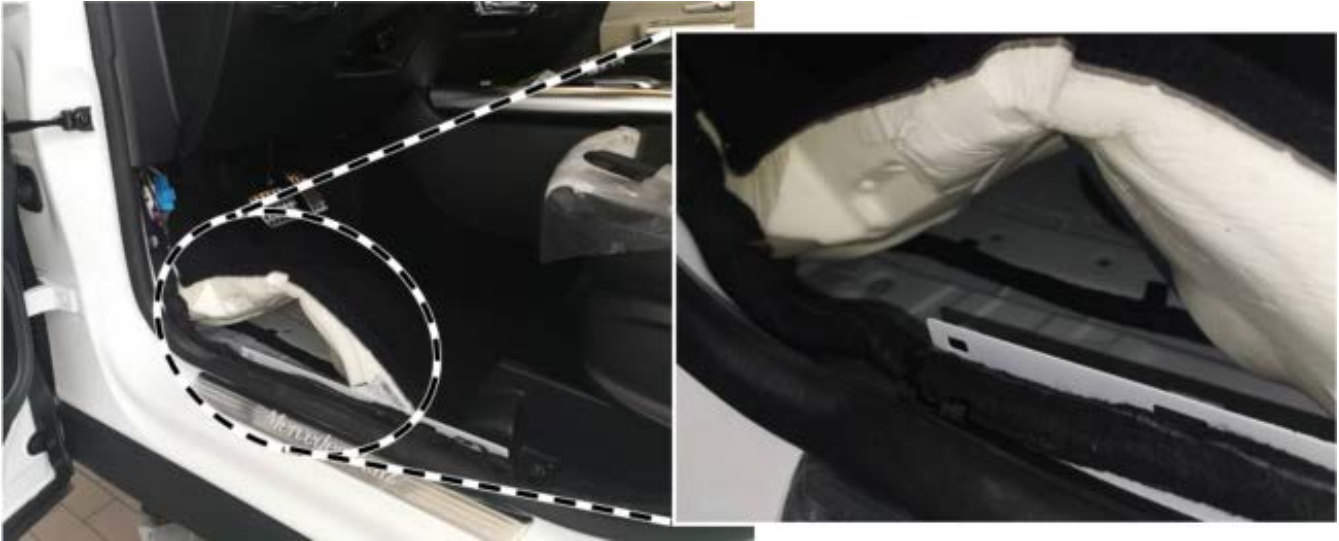
**Figure 1**

1. Remove right and left front door sills (**AR 68.30-P-4101MFA**).
2. Lift floor covering in footwell on driver's side and front passenger side and check for moisture (**Figure 1**).
i There may be no ingress of water under the floor covering in the footwell on the driver's side and front passenger side.

- a. **No** ingress of water in footwell on driver's side and/or front passenger side: Carry out **work procedure A**.
- b. Ingress of water in footwell on driver's side and/or front passenger side: Carry out **work procedures A and B**.
