**HYUNDAI**
Technical Service Bulletin

GROUP RECALL	NUMBER 20-01-023H
DATE MAY, 2020	MODEL(S) GENESIS COUPE (BK)

SUBJECT: 2016 GENESIS COUPE (BK)
DRIVER AIRBAG (RECALL CAMPAIGN 192)

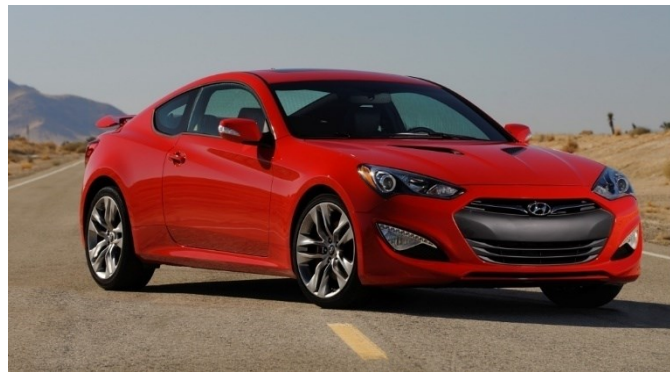
Certain Genesis Coupe vehicles are equipped with the driver airbag whose mounting bolts, which secures the driver airbag to the horn sub-assembly, may have been installed with insufficient torque during assembly. If insufficient torque was applied to the mounting bolts, the airbag may potentially detach from the steering wheel, increasing the risk of injury during a crash.

This bulletin describes the procedure to verify the torque for the mounting bolts and retighten if necessary.
