Safety Recall

Code: 70H6

Subject Leather Instrument Panel/Passenger Airbag Deployment

Release Date June 18, 2020

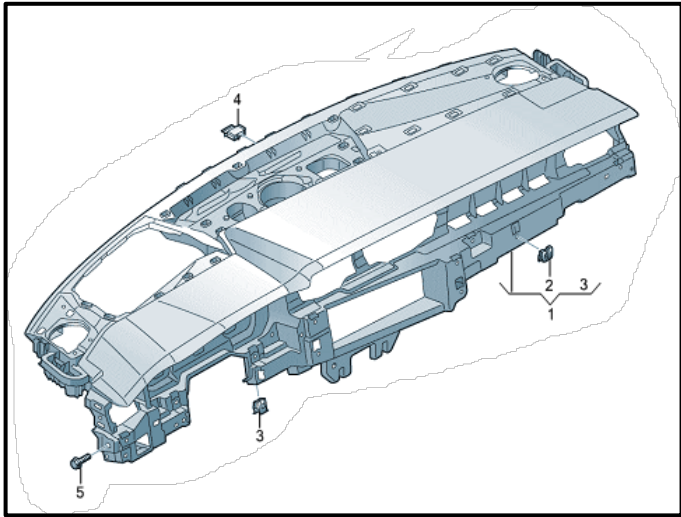
Repair Overview

Problem Description Leather covered instrument panels produced during a specific period were not manufactured according to specification by the supplier. As a result, the predetermined split lines for the passenger airbag may not open as designed in the event of a crash, potentially reducing the restraint effect of the passenger airbag. In a crash with passenger airbag deployment, the restraint capacity of the passenger airbag may be reduced and small plastic parts may enter the passenger compartment. This may lead to an increased risk of injury.

- Replace instrument panel (dashboard).
