Field campaign

Topic	New Continental GT - Sunroof glass replacement - New Flying Spur - Sunroof assembly replacement
Market area	Bentley: worldwide (2WBE)
Brand	Bentley
Transaction No.	2059318/1
Campaign number	TEST
Note	
Type	
US code

New Continental GT and New Flying Spur

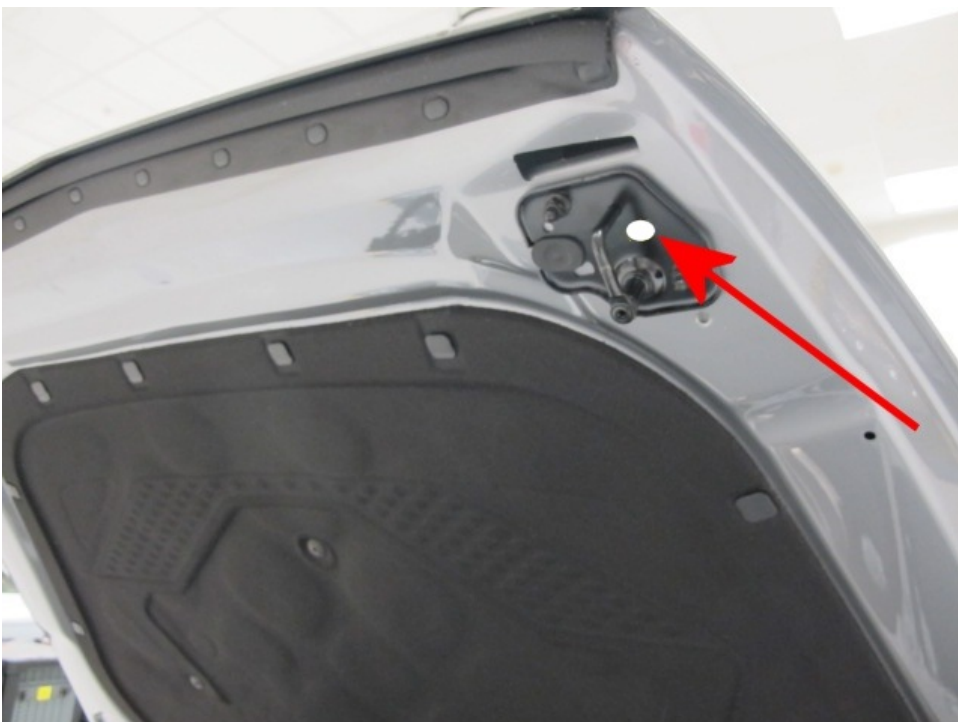
White paint identification mark as shown in Figure 1

- 1) Replace the sunroof glass – Refer to Rep.Gr 60
- 2) Place a white paint completion mark on the left hand bonnet latch striker (Figure 1)

- The rain/light sensor (if replacement is required) - Rep.Gr 92 for clarification
 - Camera for driver assist systems – To remove and fit - Rep.Gr 44
- 2) Calibrate the Camera for driver assist systems. Refer to "Calibrating front camera for driver assist systems".
 - 3) Place a white paint completion mark on the left hand bonnet latch striker (Figure 1)
