Keystone RV Company

SAFETY ADVISORY # 20-375

Kinro Frameless Windows

3000 SERIES WINDOW VENT BONDING INSPECTION

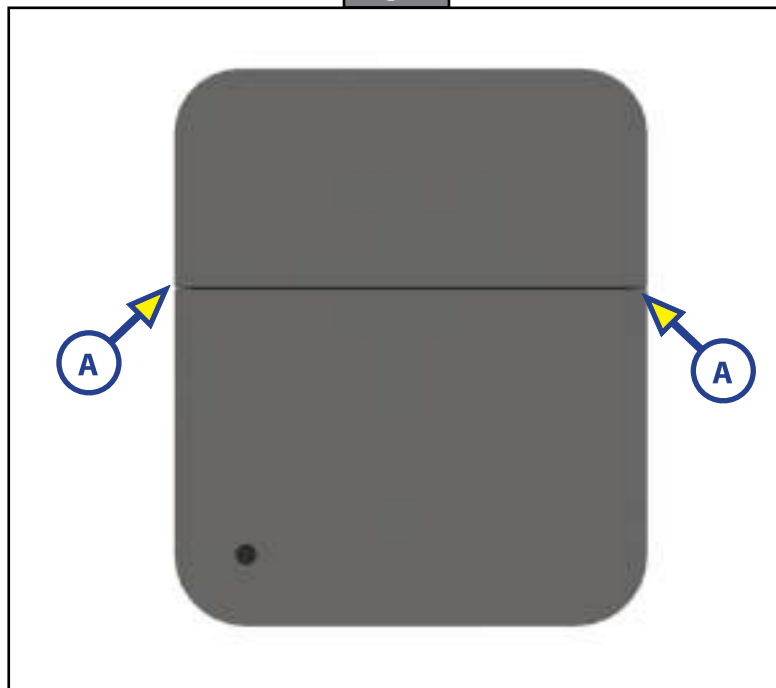
Fig. 5

1. Make sure the unit is on a level, flat surface then chock the wheels.
2. Inspect the frameless window for proper adhesive bond where the glass meets the hinge frame (Fig. 5A).

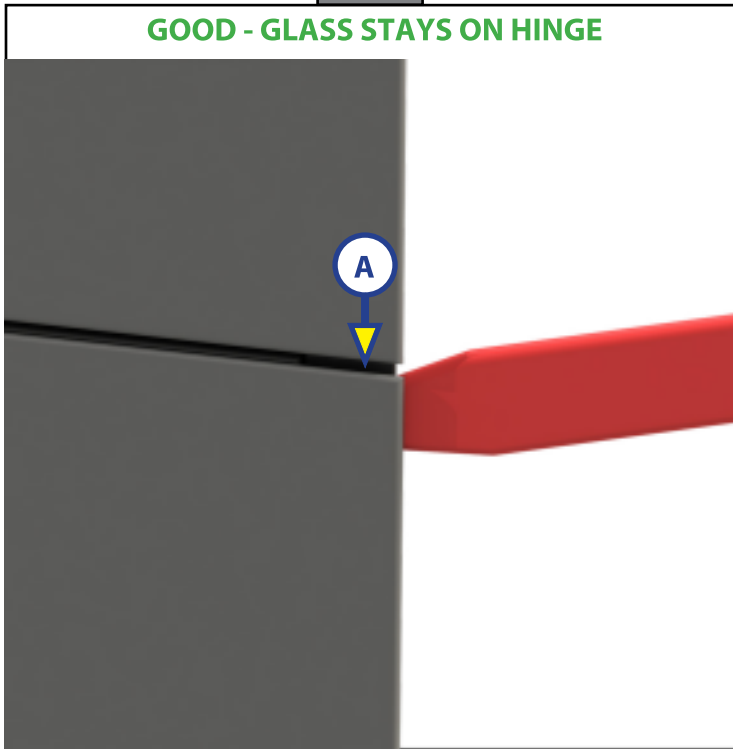
Fig. 6

4. If the glass does not separate from the hinge (Fig. 6A), it is a good bond. **DO NOT REPLACE** the vent. If the glass is not adhering to the vent (Fig. 7A), the glass **DOES NEED TO BE REPLACED**.
