TECHNICAL BULLETIN

Re:
Replacing the panhard rod ball-joint bracket bolts.

Bulletin number:
VBA-TB2020-003-ALL

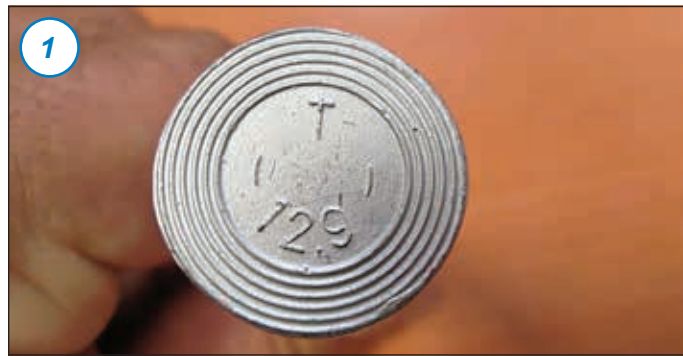
Picture 1: "wrong plough bolt type" Please exchange and discard. Fit new locking nuts and take notice of assembly instructions.

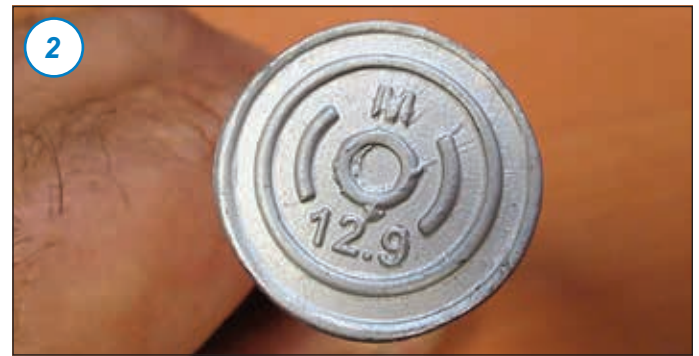
Picture 2: "Correct plough bolt type". No further action needed.
