# Technical information

**TI No.: 75.00U20104A**
**Distribution list: D**
**Distribution date:**
**12.08.2020**
**Valid until: 31.12.2040**
**The point of contact is the EvoBus after-sales service in each country**

| Model: | TC 400 USA |
| <b>TITLE:</b> | <b>TC 400 USA - completing the weld seams on the brackets of the engine compartment flap</b> |

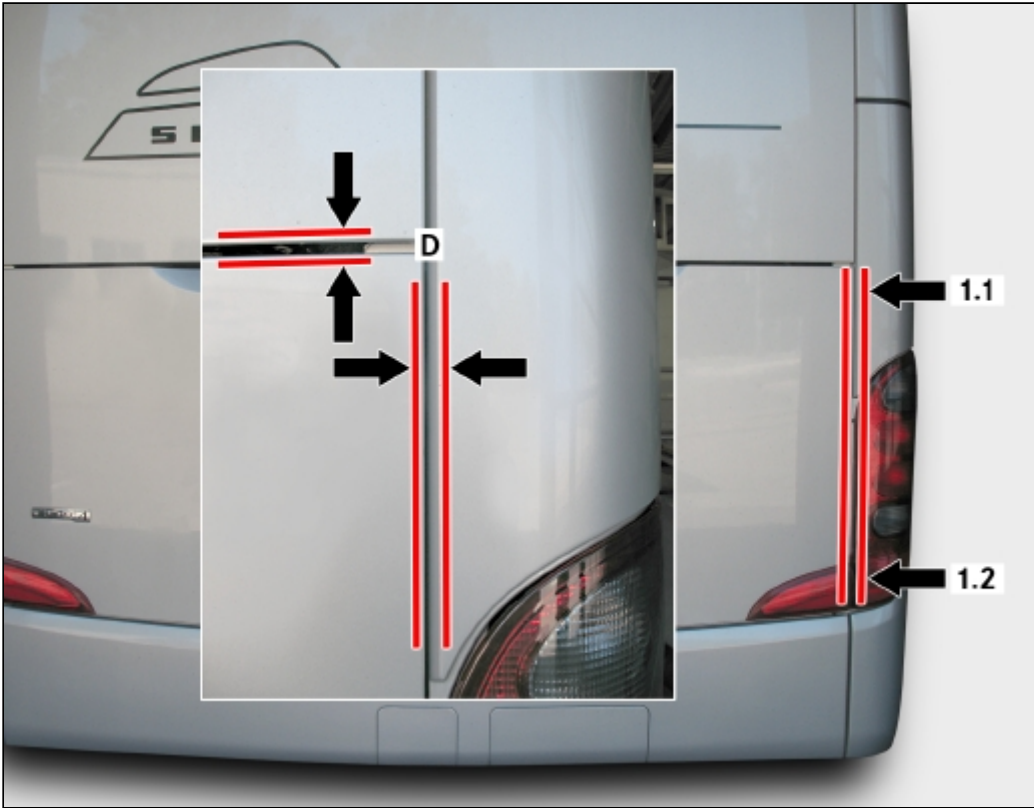
M88.50-0001-81

| Reference values | |
| Engine compartment flap gap dimension (D) | 6 ... 10 mm |

| Reference values | |
| Uniform gap line from (1.1) to (1.2), permissible deviation | 1.5 |

Adjust all gaps around the engine compartment flap in such a way that their dimensions are as equal as possible. The maximum relative deviation is 1.5 mm.

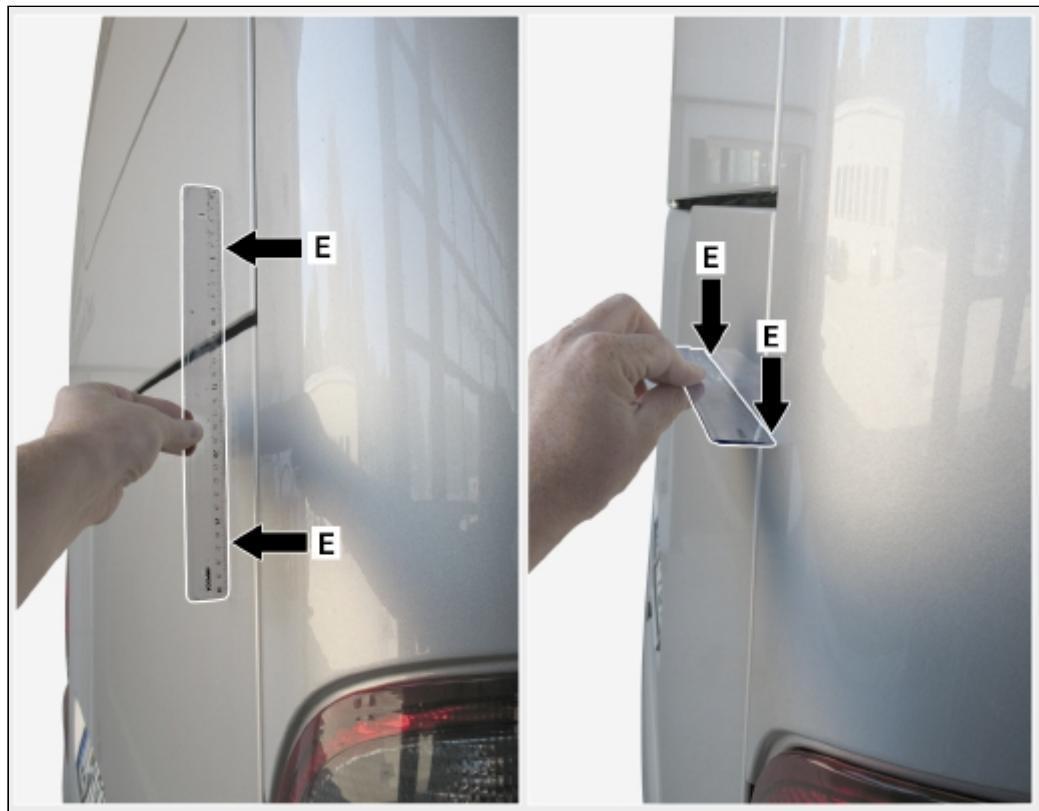
M88.50-0002-81

| Reference values | |
| Transitions (planar alignment) (E) from the outer surface to all adjacent components | $0^{+1.5}_{+1.5}$ mm |
