Revision (2) November 2021

Dealer Service Instructions for:

Safety Recall W09 / NHTSA 20V-396 Driver Air Bag Emblem

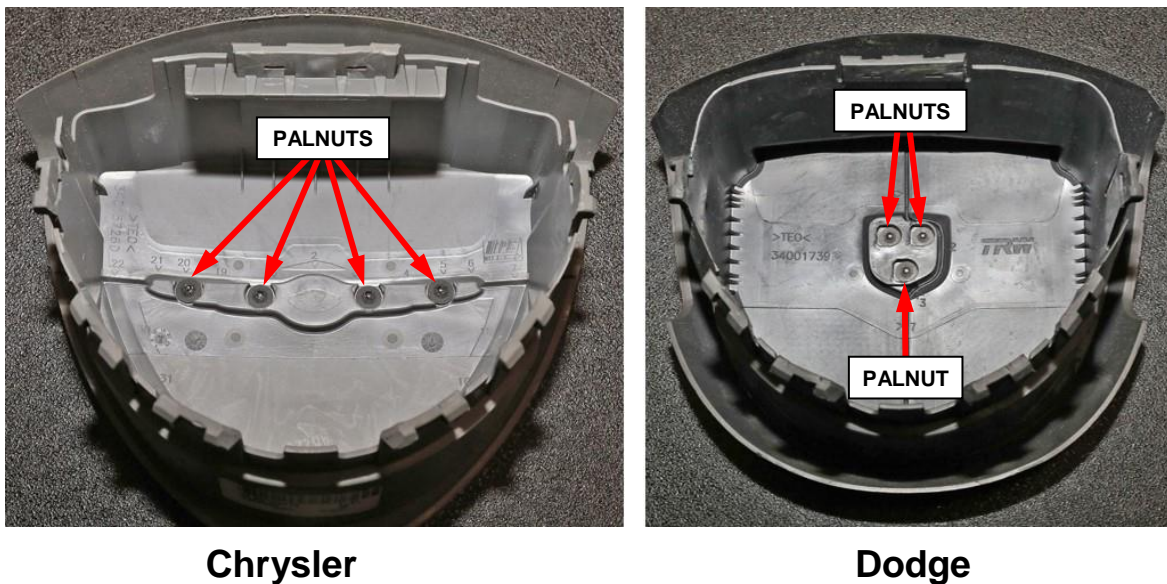
**Chrysler****Dodge****Figure 14 – Emblem Palnut Retainers**

9. Verify that all palnut retainers and emblem pieces are accounted for (Figure 14).
 - Chrysler emblems have four palnut retainers.
 - Dodge emblems have three palnut retainers.

If necessary, carefully inspect the air bag cushion folds for any trapped palnut retainers or emblem post pieces. Be careful to not unfold the air bag too far because it needs to be folded back exactly as it was prior to inspecting.

10. After all palnut retainers and emblem pieces are accounted for. Place the air bag and inflator assembly in a clean safe place **away** from the DAB cover work area to prevent any air bag contamination from debris.
11. Are all palnut retainers securely attached to emblem or are any palnut retainers loose not securely attached to the emblem?
 - If **ALL** palnut retainers are securely attached to the emblem:
Proceed to **Section C. Tape Installation.**
 - If one or more palnut retainers are loose or detached from the emblem:
Proceed to **Section D. Cover Replacement.**

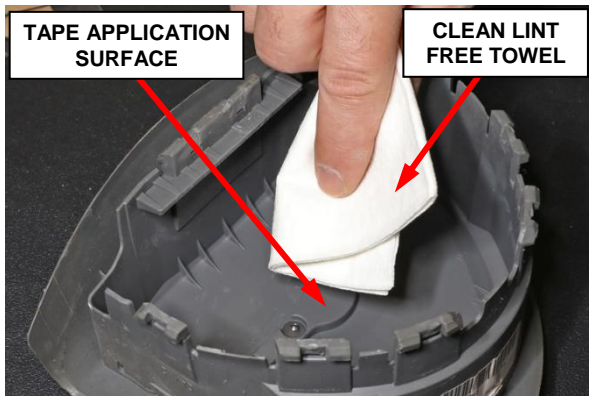
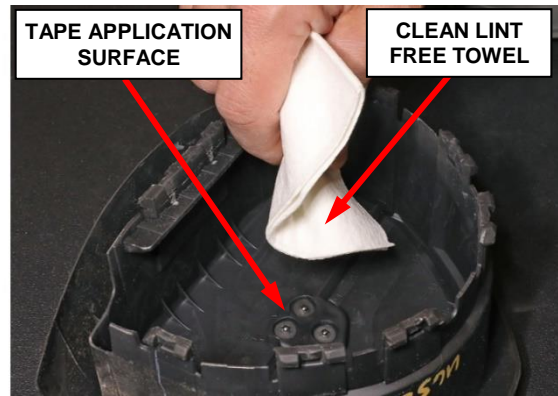
Figure 15 – Wipe Clean Tape Application Surface Inside DAB Cover

NOTE: This repair is ONLY for DAB emblems which are securely attached with ALL palnut retainers.

1. Use a clean lint free towel to wipe the inside surface of the DAB cover where the tape will be applied in order to remove any lint or debris (Figure 15).

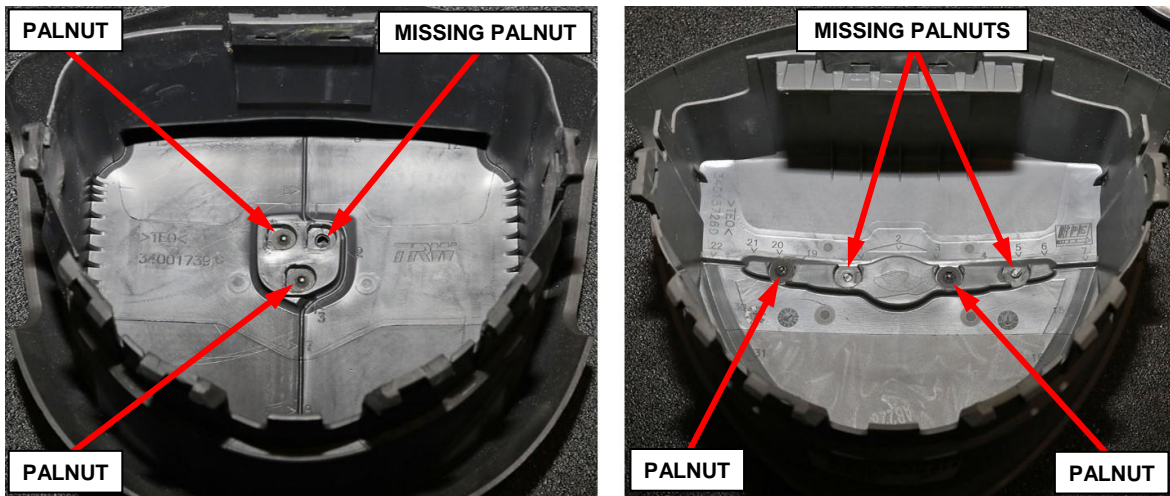
Figure 17 – Emblem Palnut Retainers

NOTE: This repair is for DAB emblems which are partly or fully detached due to one or more loose or missing palnut retainers.

1. Verify that all palnut retainers and emblem pieces are accounted for and disposed of so as to not contaminate the air bag cushion during reassembly. (Figure 17).
2. Discard the old DAB cover including any detached palnuts and emblem pieces.
