# Safety Recall

## Code: 51G6

**Subject** Engine Compartment Seal

**Release Date** September 18, 2020

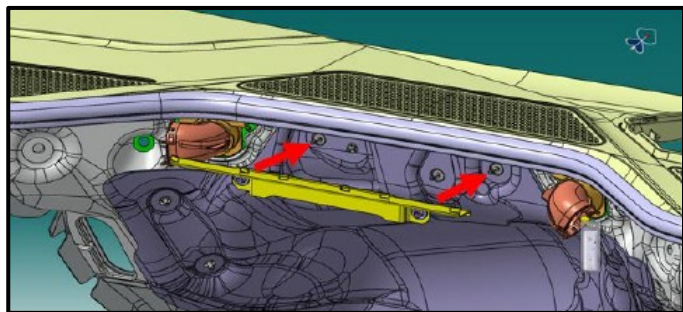
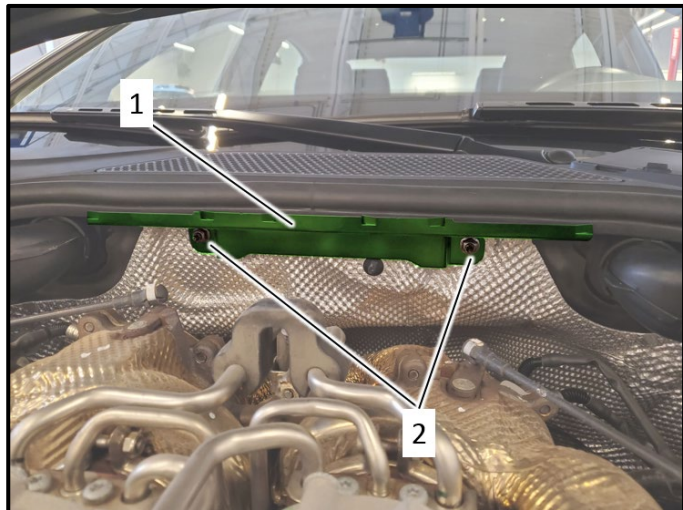
The retaining plate will prevent the engine compartment seal from falling onto the exhaust.

- Ensure engine compartment seal is completely installed on the water box/plenum chamber cover.
- Install new retaining plate <1> over the existing studs on the water box/plenum chamber cover.
- Install new nuts <2> and torque to 8 Nm.
