Keystone RV Company

SAFETY ADVISORY # 20-381

Carbon, Cougar, Fuzion, Impact, and Raptor Fifth Wheel TV Antenna

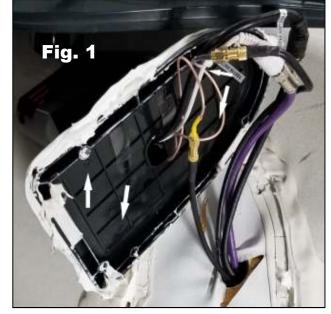
Keystone is conducting a voluntary RECALL notification campaign in accordance with the National Highway Transportation and Safety Act. It has been decided some Furrion over the air (OTA) antenna wings are separating from the mounting base on certain fifth wheel models. If the antenna wing completely separates from the mounting base while the recreational vehicle is in transit, it could become a road hazard, potentially increasing the risk of a crash or injury.

Locate the mounting base for the Furrion antenna and remove the exterior 7 screws to detach it from the roof. Remove the 4 screws out of the bottom of the base and pull the mount for the 4G antennas out of the base, Figures 1 and 1a. Discard the unused portion of the mounting base.
