Keystone RV Company

SAFETY ADVISORY # 20-381

Carbon, Cougar, Fuzion, Impact, and Raptor Fifth Wheel TV Antenna

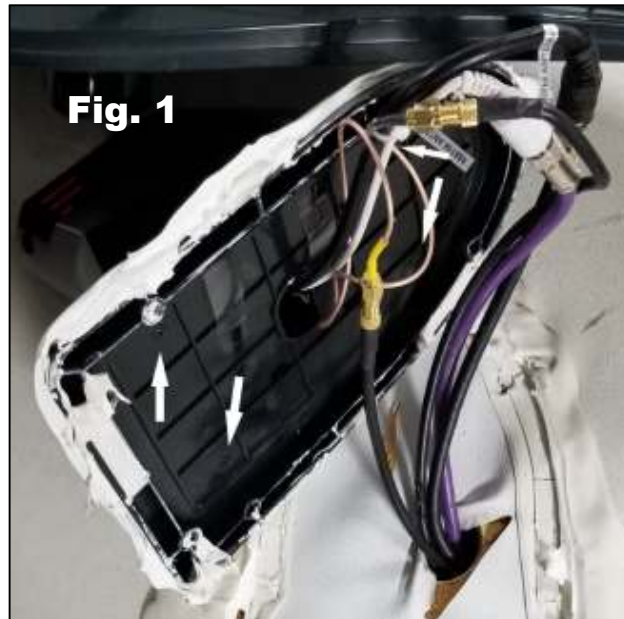
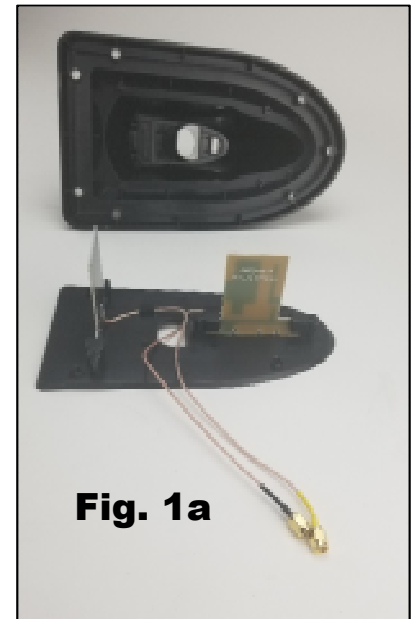
Keystone is conducting a voluntary RECALL notification campaign in accordance with the National Highway Transportation and Safety Act. It has been decided some Furrion over the air (OTA) antenna wings are separating from the mounting base on certain fifth wheel models. If the antenna wing completely separates from the mounting base while the recreational vehicle is in transit, it could become a road hazard, potentially increasing the risk of a crash or injury.

Locate the mounting base for the Furrion antenna and remove the exterior 7 screws to detach it from the roof. Remove the 4 screws out of the bottom of the base and pull the mount for the 4G antennas out of the base, Figures 1 and 1a. Discard the unused portion of the mounting base.
