MODEL  
**2020MY  
Sedona (YP)**

NUMBER  
**SC192**

### ALTERNATOR B+ TERMINAL NUT INSPECTION AND TIGHTENING (SC192)

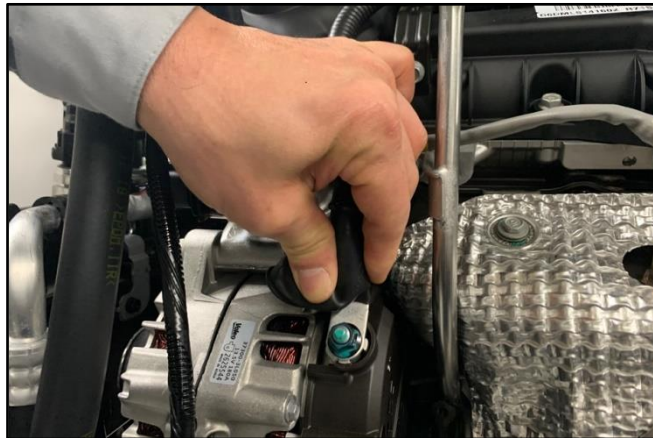
This bulletin provides information to inspect and, if necessary, tighten the Alternator B+ terminal nut on some 2020MY Sedona (YP) vehicles equipped with the 3.3L GDI engine and produced from August 1, 2019 through April 20, 2020. The Alternator B+ terminal ensures the electrical connection is maintained between the battery wire harness terminal plate and the Alternator B+ terminal, but the B+ terminal nut may not have been properly torqued during assembly. If the terminal nut is not properly torqued, it may loosen over time and come off, resulting in electrical arcing at the B+ terminal and possible fire. Before conducting the procedure, verify that the vehicle is included in the list of affected VINs.

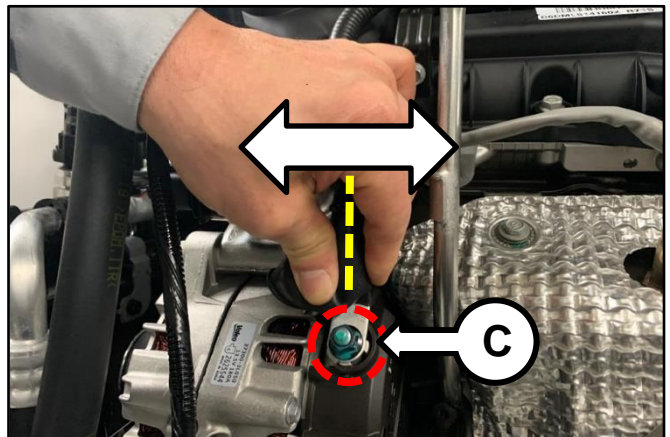
3. Inspect the B+ terminal and confirm the nut (C) is properly secured by attempting to move the terminal end left to right.

**Note:** The alternator B+ terminal cable should be connected vertically (refer to the yellow dashed line).

If the cable end/nut is loose (FAIL), then torque the nut (C) to specification.

**Torque Specification for nut (C):**  
8.7 lb.ft (11.8 N.m., 1.2 kgf.m)
