TECHNICAL INSTRUCTIONS

SAFETY RECALL 20TA12

FRONT TURN SIGNAL BULB BRIGHTNESS

CERTAIN 2018 - 2020 TUNDRA

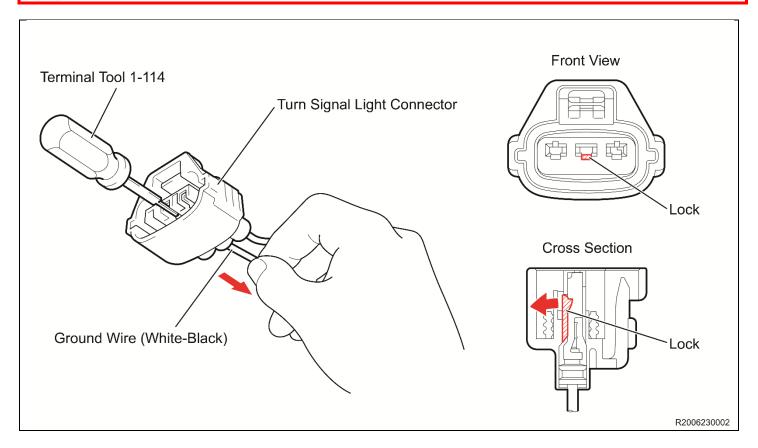
a. Identify the white wire with a black stripe, located in the center cavity of the connector.

b. Using the supplied Terminal Tool 1-114, release the primary lock of the terminal while pulling outward on the wire to remove it from the connector. **DO NOT** overstress the terminal lock or it will not properly hold the terminal when reassembled.

When inserting the Terminal Tool 1-114, pry carefully outward just enough to remove the terminal from the wire side. Excessive pressure may damage the lock, or bend the tool.

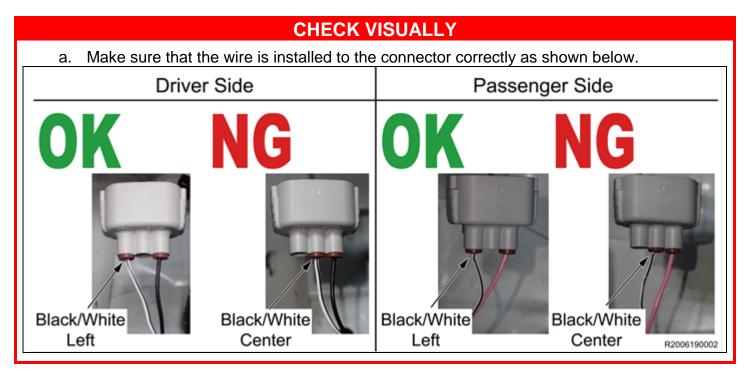
a. Install the rubber sealing plug into the center connector cavity.

DO NOT LOSE THE RUBBER SEALING PLUG!
