SIB 32 02 20

RECALL 20V-434: REWORK STEERING SPINDLE (STOP DRIVE).

This Service Information Bulletin (Revision 2) replaces SI B32 02 20 **dated July 2020**.

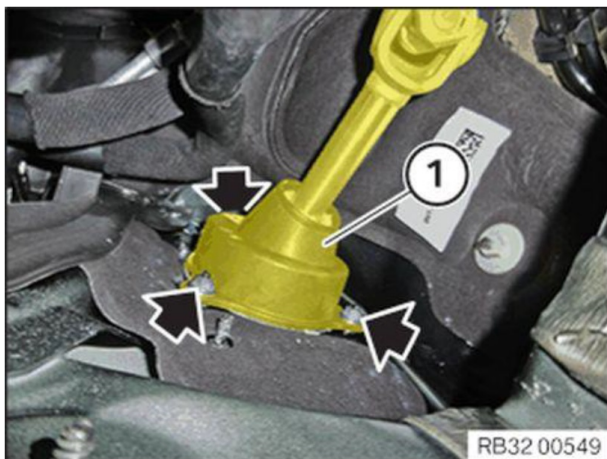
2. Using a borescope ([SI B04 08 17](#) or [B04 14 18](#)) identify the 3 nuts securing the steering spindle (1) to the bulkhead.

**Note:** Photo is shown looking up from underneath the vehicle.

3. Using a 10mm socket on a long extension, check whether the 3 nuts can be turned by hand. Document finding on the attached Feedback Form.

4. Inspect the steering shaft collar position.

Are the collar guides still on the stud bolts of the bulkhead?

**No:** Replace the steering shaft as per REP 32 21 070

**Yes:** Tighten the nuts to the specified torque 8 Nm as per the REP 32 21 070 and, if necessary, replace the nuts if found to be damaged. **Do not use a swivel adapter when torquing the nuts.**
