Field campaign

Topic	Flying Spur - Top View and Rear View Cameras - Images Blurred (RE20/21)
Market area	United States E05 Bentley USA and rest America (6E05)
Brand	Bentley
Transaction No.	2060304/2
Campaign number	RB63
Note	
Type	Recall Campaign
US code

Flying Spur

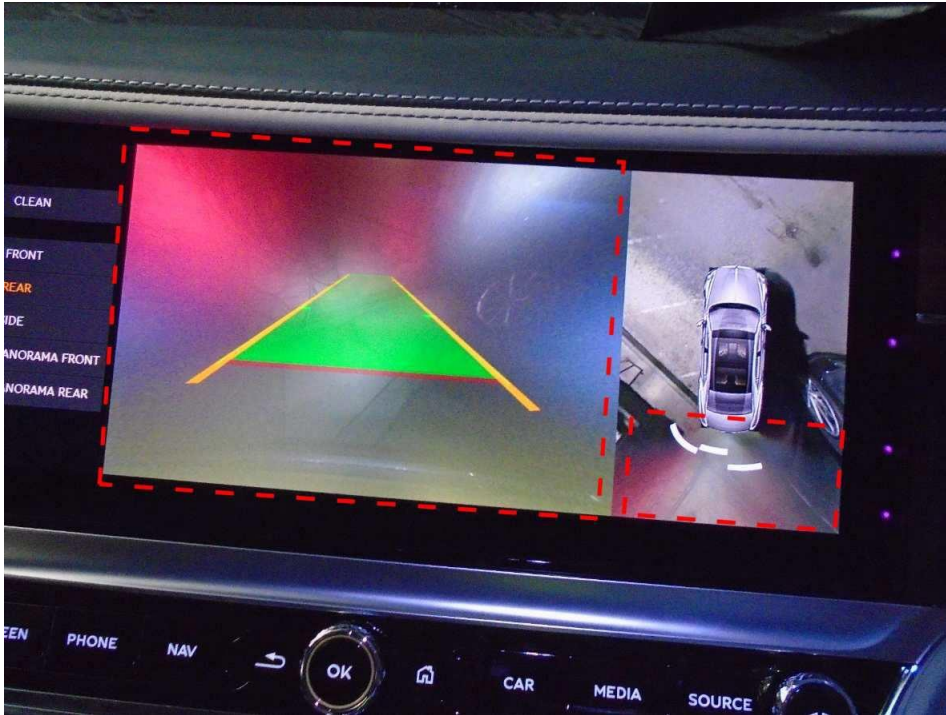
Figure 1.

It is possible for moisture to accumulate within the rear view camera, as a result the Top View and Rear View Camera images may appear blurred or cloudy – *figure 1*.

The holder of the camera unit was built without any drain feature. Without a drain feature, moisture can become trapped between the holder and the camera unit subsequently resulting in a reduction in image clarity.

Addition of a drain hole within the Rear View Camera securing bracket.

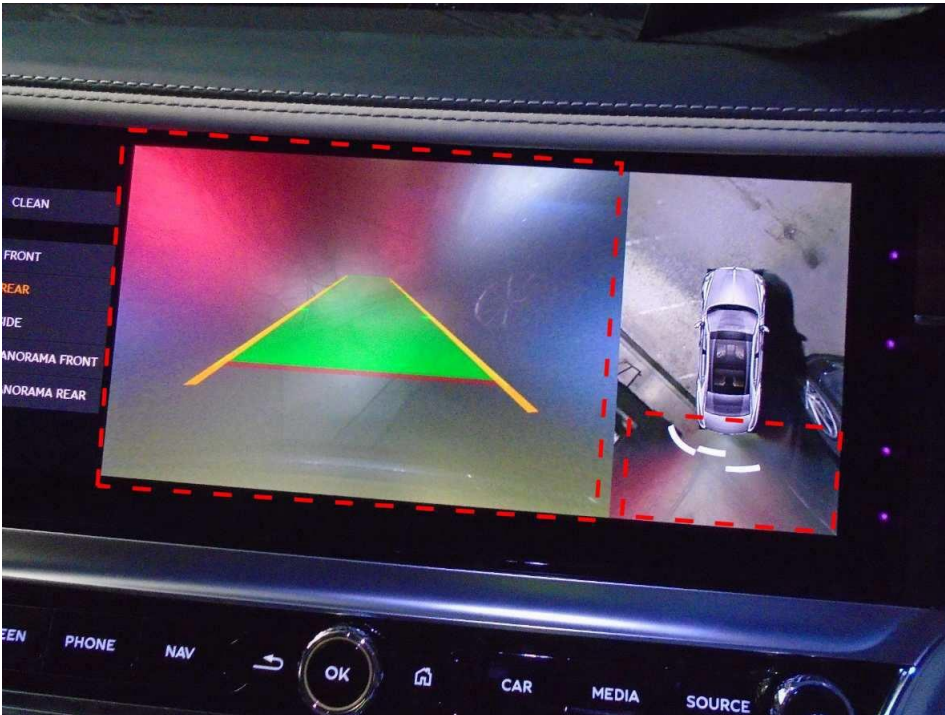
Figure 1.

It is possible for moisture to accumulate within the rear view camera, as a result the Top View and Rear View Camera images may appear blurred or cloudy – figure 1.
