RECALL

R20AY – Steering Wheel Nut Torque Confirmation

Models Affected: Certain 2021 Model Year Vision Buses

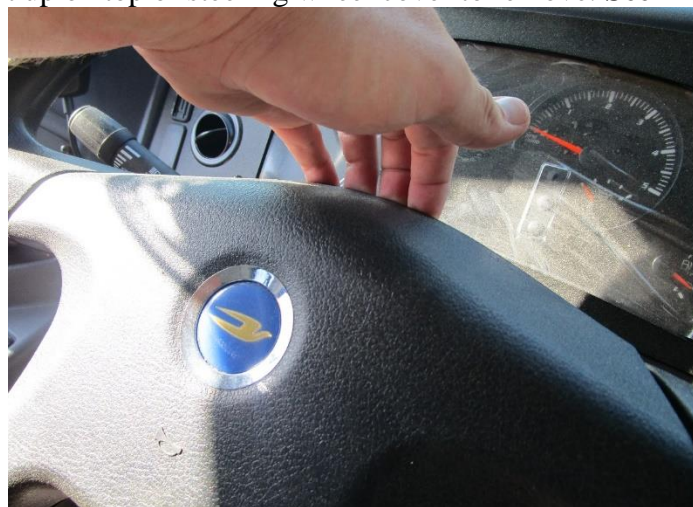
Photo 1

Issue: The nut that retains the steering wheel to the steering shaft may not have been torqued to factory specifications on the affected buses.

1. Lift up on top of steering wheel cover to remove. See Photo (1)

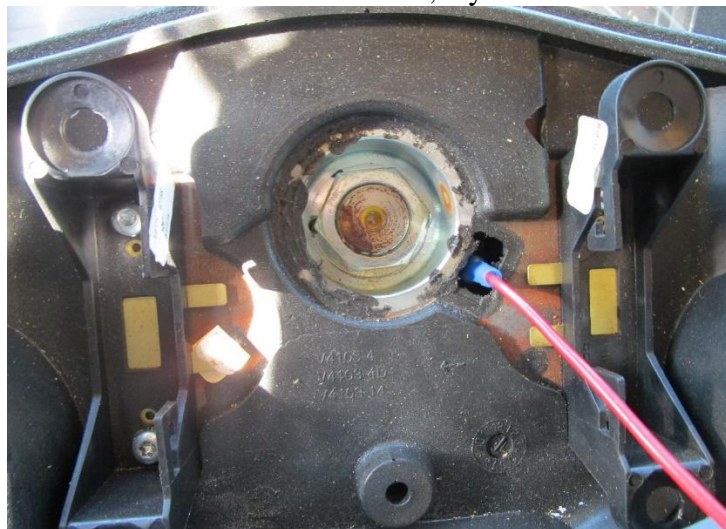
2. The cover contains the horn wire, lay the cover to the bottom.

3. Torque the steering wheel nut to 40-50ft lbs.
4. Ensure the horn wire is securely connected, then reinstall the steering wheel cover by pressing bottom portion in first followed by top of steering wheel cover until secure.
