2018FA07, Rev. C  
July 17, 2020  
Page 1 of 9

SUBJECT: H 40/50 EP™ Drive Unit C1/C2 Pressure Switch

MODELS AFFECTED: H 40/50 EP™ Drive Unit

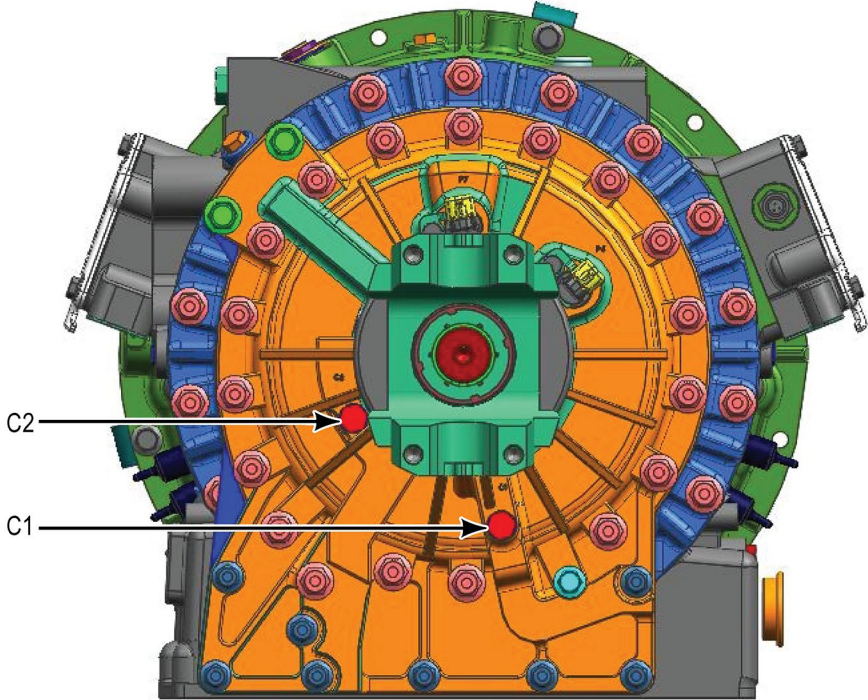
Figure 4.

4. Remove the C1 and C2 plugs (shown below) on the backside of the rear cover.
