Mercedes-Benz

Campaign No. 2020090006, October 2020
Revision A 8/23/2021

SUBJECT: **Model GLB-Class vehicles (247 platform)**
Model Year 2020
Check Rear Spoiler

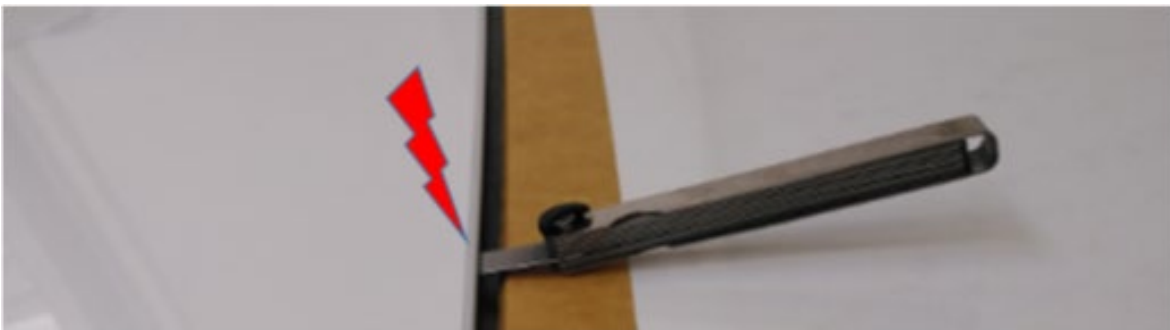
Figure 5 (not OK)

i It **must not be possible** to slide the gauge between the spoiler lip and the outer shell of the center rear

spoiler. (Figure 5, not OK)

1. Replace center rear spoiler (**AR72.20-P-4000MFD**).

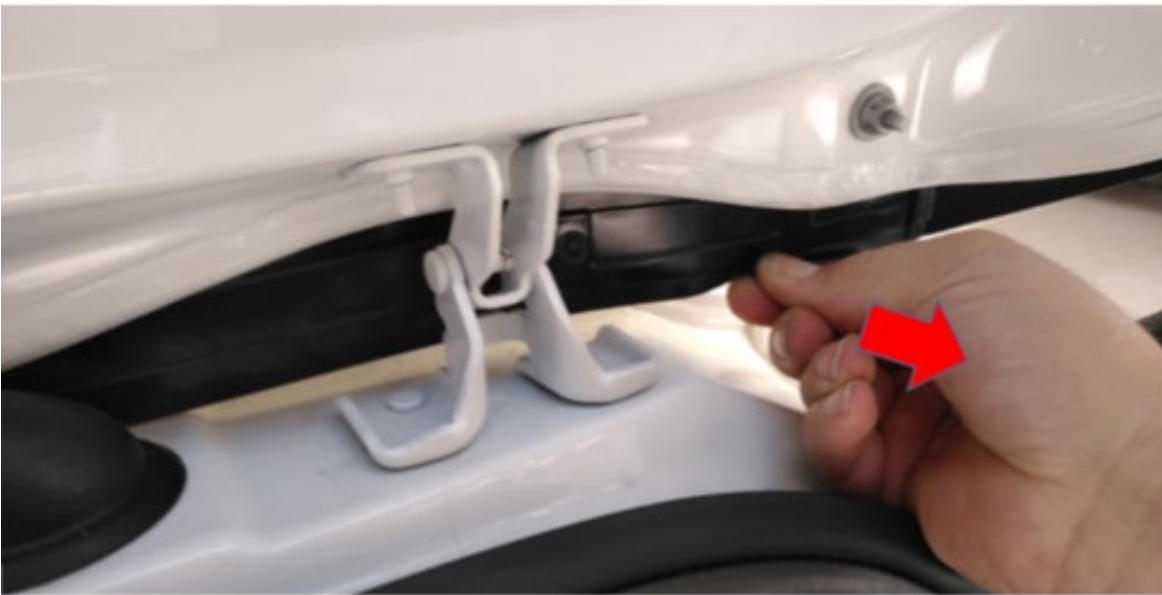
Figure 7

5. Carefully pull on the spoiler lip in the area of the hinges on the left and right of the tailgate.

i The spoiler lip **must not** detach from the outer shell of the center rear spoiler.

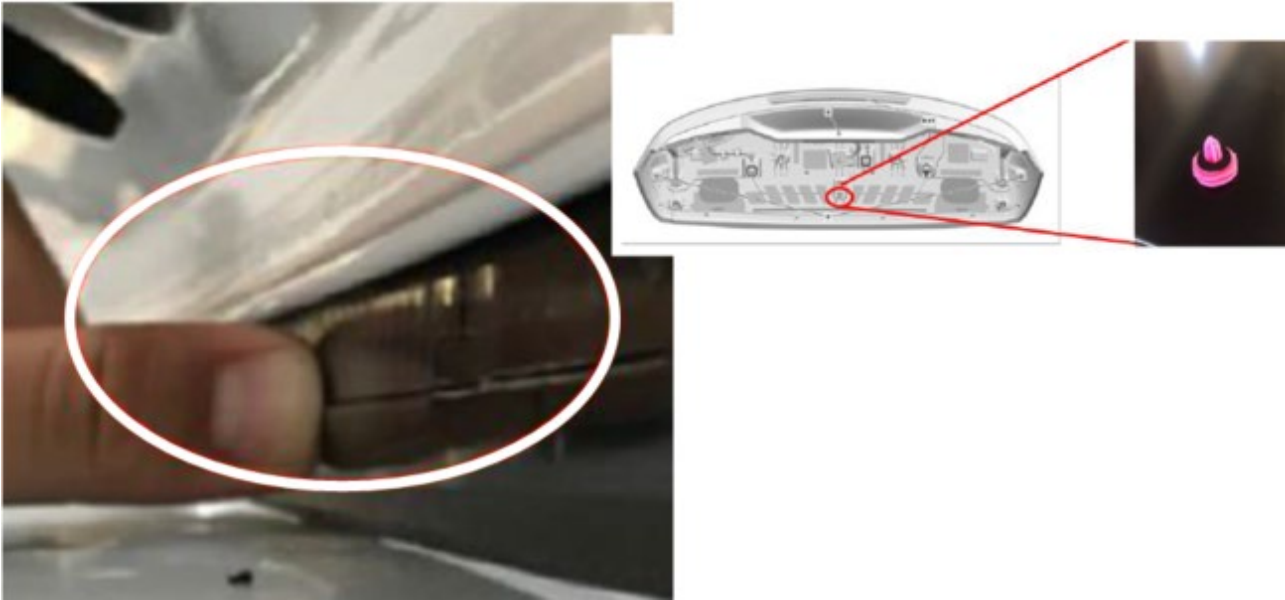
Figure 9

7. Check whether the retaining clip in the center of the center rear spoiler is engaged.

i To do so, fully open the tailgate and then lower it by **approx. 25 cm**. The test is meaningful only in this position.

i While the tailgate is open, press against the center rear spoiler from the inside with your thumbs (force applied: approx. 10 lbs.).

i If the center rear spoiler can easily be pressed against the roof edge the center retaining clip is not engaged and possibly damaged.

1. Remove center rear spoiler and replace all retaining clips, screws, and adhesive strips.
 - i** For basic data, see **AR72.20-P-4000MFD**.
 - i** Check whether the retaining clips of the center rear spoiler are engaged correctly after the repair.
-
