VSR-TSB-028

NHTSA Campaign Number: 20V-499

Vehicle Safety Recall - Technical Service Bulletin

Attention: Oshkosh Product Owner
Subject: Bendix Pressure Switch
Models Affected: Oshkosh S-Series Front Discharge Mixer
Model Year: 2020
Date: September 2020

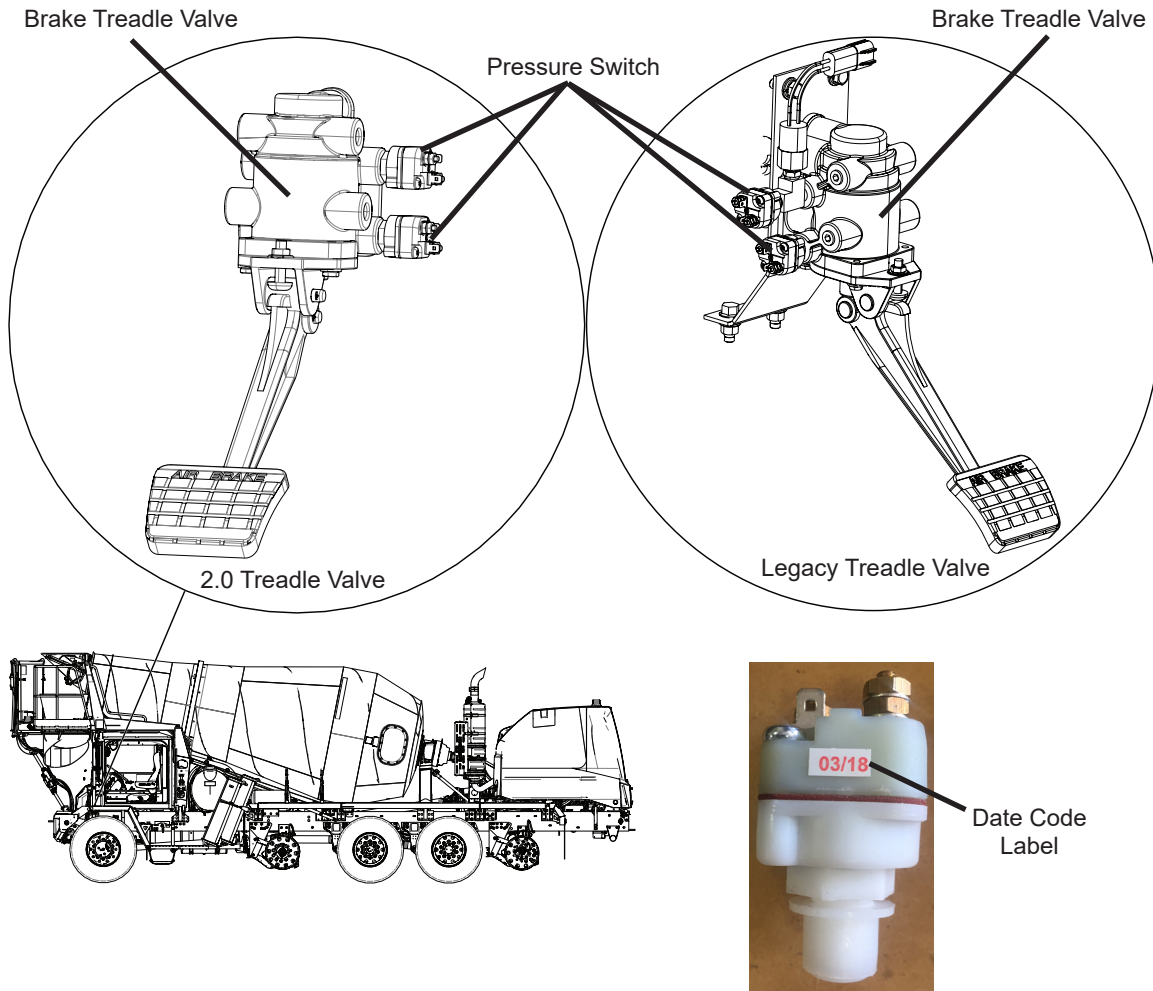
Figure 1. Brake Treadle Valve

3. Locate the two Bendix pressure switches installed on the brake treadle valve, see Figure 1.
4. Check the pressure switch lot number date code label. Suspect lots include 12/19 and 01/20. See Figure 1.

- A. If either of the pressure switches lot number date code label does not include 12/19 or 01/20 this procedure is complete and no further action is required. Remove your company's Lockout/Tagout procedure. If your company does not have a Lockout/Tagout procedure, follow OSHA 1910.147 and 1910.146 Confined Space as appropriate. Remove the wheel chocks. Return the vehicle to service.
- B. If either of the pressure switches lot number date code label includes 12/19 or 01/20 or the date code label is missing **Do not run or use the vehicle**, maintain your company's Lockout/Tagout on the vehicle, and replace the pressure switch(es) per the replacement procedure.

1. Disconnect harness connections from the pressure switch.
2. Loosen and remove the pressure switch from the brake treadle valve.
3. Apply Loctite® 567 sealant to the threads of new pressure switch.
4. Install pressure switch in brake treadle valve. Final tighten pressure switch hand tight plus 2-3 turns.
5. Reconnect harness connections to pressure switch.
