September 2020

Dealer Service Instructions for:

# **Safety Recall W57 / NHTSA 20V-511 Powertrain Control Module Software**

**2019 - 2020 (DD) Ram 3500 Cab Chassis  
(DP) Ram 4500/5500 Cab Chassis**

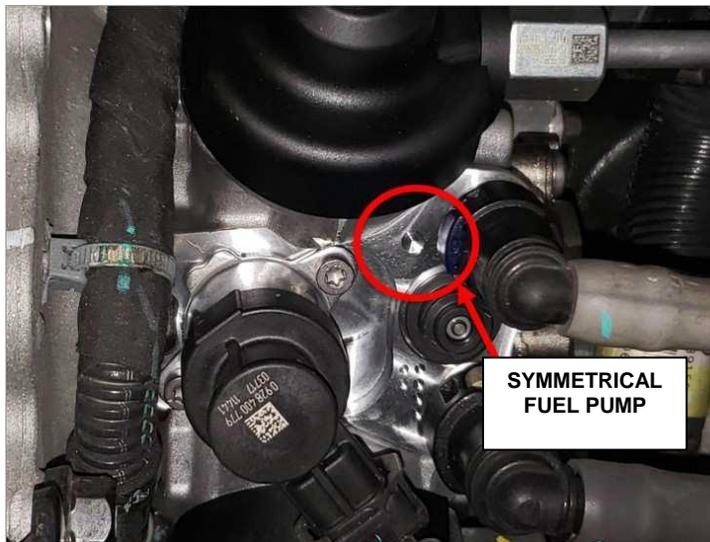
Figure 1 – Symmetrical Fuel Pump

1. Inspect the fuel injection pump to see which pump the vehicle has.
- Vehicles with the new style **Symmetrical** pump will have one large single dot embossed in the pump housing (Figure 1).

- For vehicles equipped with a **Symmetrical** pump, choose the calibration labeled **Symmetric**, or **Sym Pump** (Figure 1).
- Vehicles with the old style **Asymmetrical** pump will have multiple dots embossed in the pump housing (Figure 2).
- For vehicles with an **Asymmetrical** pump, choose the calibration labeled **Asymmetric** or **Asym Pump** (Figure 2).
