**HYUNDAI**  
**Technical Service Bulletin**

GROUP <b>RECALL</b>	NUMBER <b>20-01-046H</b>
DATE <b>December, 2020</b>	MODEL(S) <b>SANTA FE SPORT (AN)</b>

**SUBJECT:** ABS MODULE INSPECTION (RECALL CAMPAIGN 194)

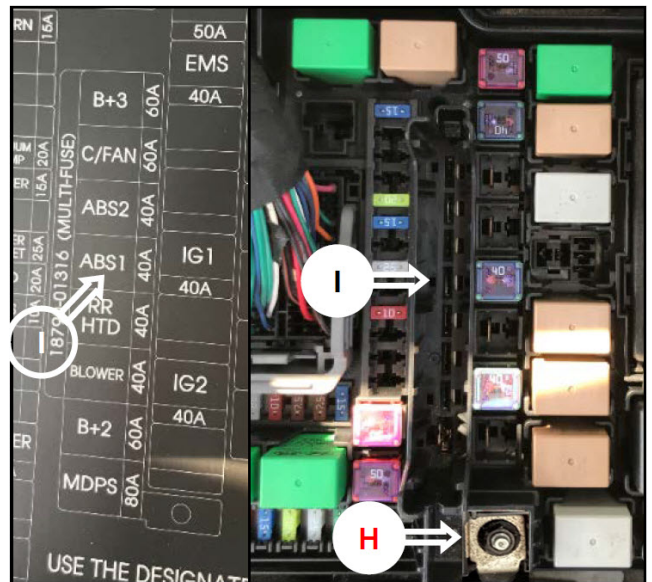
- Place the **red** lead probe of the multimeter against the side of the junction box stud (H). Place the **black** lead probe on the ABS1 terminals (I) in the junction box.

- Measurement must be taken for at least 15 seconds to obtain a stable reading.
- Use care not to damage the ABS1 terminals in the junction box with the multimeter black lead probe.

7. If the measured current value **is 70uA or greater, replace the Hydraulic Unit Assembly (HECU).**

If the measured current value is **less than 70uA**, HECU replacement is not needed at this time.
