HYUNDAI Technical Service Bulletin

GROUP RECALL	NUMBER 20-01-040H
DATE October, 2020	MODEL(S) Tucson (TL)

SUBJECT: 2019-2021MY TUCSON (TL) ABS FUSE KIT INSTALLATION AND SOFTWARE UPDATE (RECALL CAMPAIGN 195)

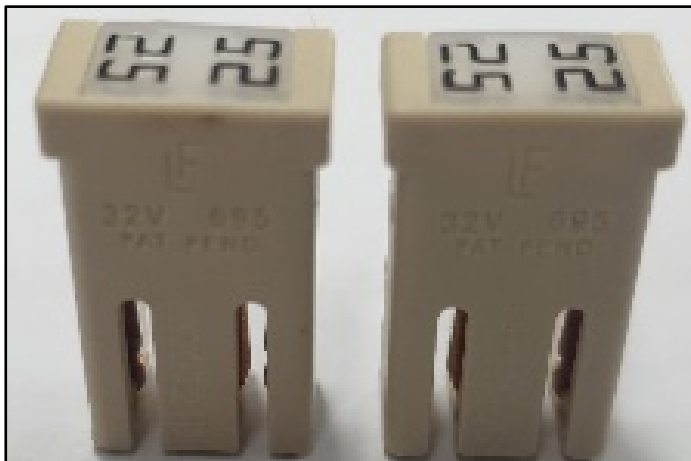
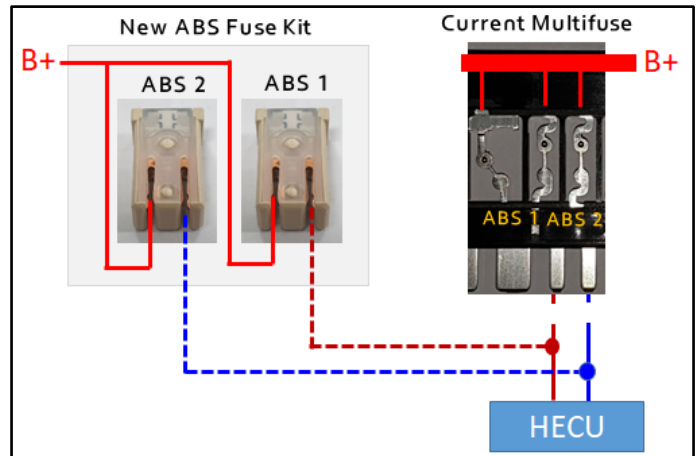
Description: Certain 2019-2021MY Tucson (TL) vehicles may be equipped with Anti-lock Brake System ("ABS") modules that over time could exhibit an electrical short. An electrical short in the ABS module could increase the risk of an engine compartment fire. This bulletin describes the procedure to install a fuse kit into the ABS module electrical circuit and if necessary, update the ABS/ESC software.
