Technical Service Bulletin

GROUP RECALL	NUMBER 21-01-010H
DATE February, 2021	MODEL(S) Tucson (TL)

SUBJECT: 2016-2021MY TUCSON (TL) ABS FUSE KIT INSTALLATION AND SOFTWARE UPDATE (RECALL CAMPAIGN 195)

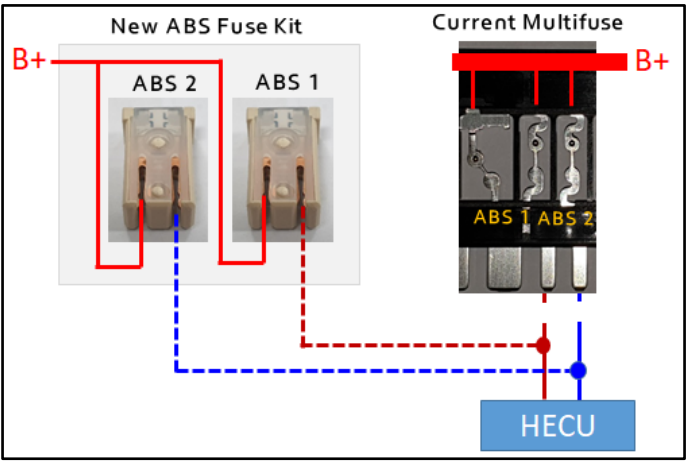
Description: Certain 2016-2021MY Tucson (TL) vehicles may be equipped with Anti-lock Brake System ("ABS") modules that over time could exhibit an electrical short. An electrical short in the ABS module could increase the risk of an engine compartment fire. This bulletin describes the procedure to install a fuse kit into the ABS module electrical circuit and if necessary, update the ABS/ESC software.
