# Campaign Service

CB20-N-002

**GROUND CABLE REPLACEMENT – 20V-###**  
(Transport Canada 2020-###)

- 2018-2021MY Isuzu FTR Vehicles Produced Before 8/14/2020

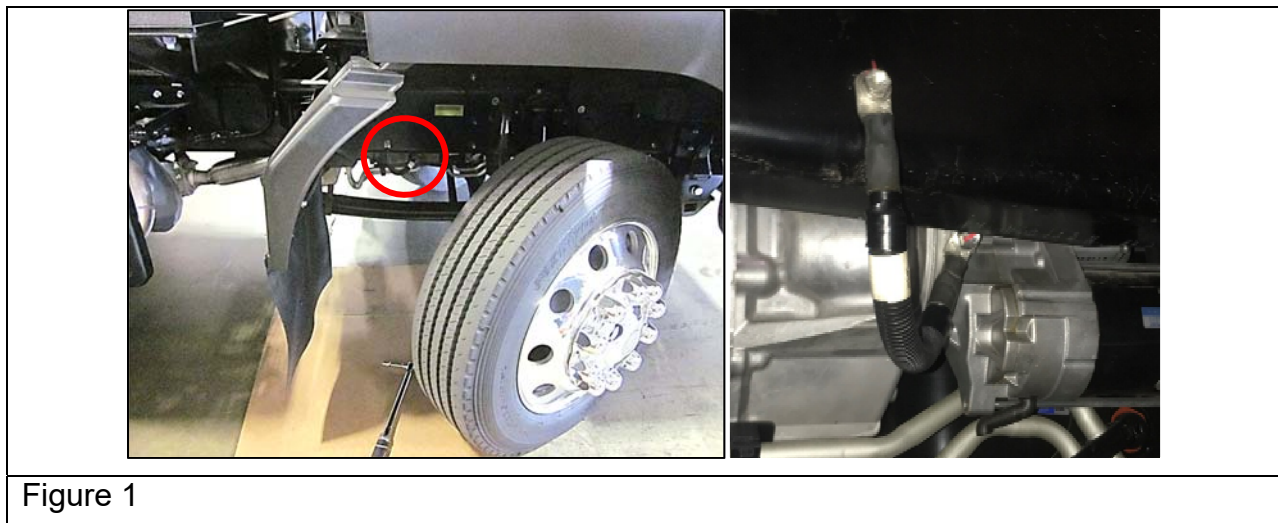
1. Place the vehicle in park, apply the parking brake, turn the engine off and block the rear tires.
2. At right side of vehicle, close to rear of the front tire, locate the ground cable. See Figure 1.

3. Using ratchet, extension and socket, remove bolt from frame, bolt from starter and remove the ground cable. See Figure 1.
4. Clean the area of the frame and the starter where the ground cable is mounted. Remove any rust or dirt that may interfere with the connection.
5. Using previously removed bolt, attach new ground cable (Starter Earth Cable) to starter first. Ensure part number label is toward starter and ensure flat side of eyelet is flush to starter housing; Torque to 40 Nm (30 ft.lb.). See Figure 2.
