October 2020  
FL861AB  
NHTSA #20V-529

## Subject: FCCC Motorhome Valve Stem Stabilizers

**Models Affected: Specific Model Years 2017 - 2020 FCCC MC, XCL, XCM, XCR, and XCS chassis manufactured February 20, 2017, through August 15, 2020, and equipped with a valve stem extension and stabilizer configured with a specific tire valve stem and wheel combination.**

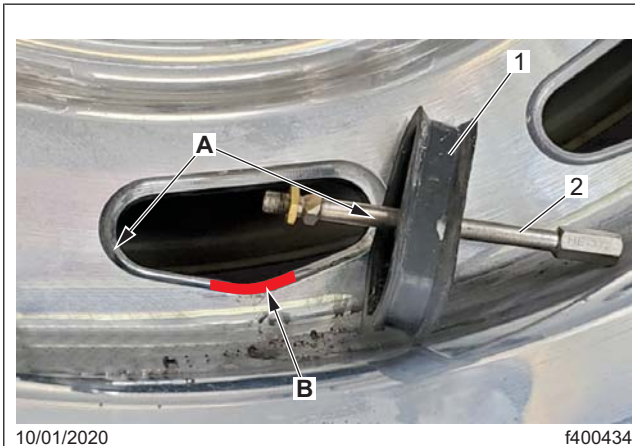
**Fig. 1, Valve Stem with Stabilizer**

4. Inspect the valve stem extensions for rubbing on the outer wheel rim opening on both drive axle wheels. Also inspect the valve stem stabilizer, which may be dislodged from the wheel rim opening.

Due to the rotation of the wheel, the 'top' of the wheel rim opening is reversed and appears at the bottom in this photo.

- A. If the valve stem extension is rubbing the side of the wheel rim opening, gently swivel the inner valve stem so that it aligns with the center of the wheel rim opening.
- B. If the inner-wheel valve stem extension is rubbing at the top of the wheel rim opening (shown here at the bottom of the wheel rim opening due to the rotation of the wheel in the photo), or if the valve stem stabilizer is dislodged, remove the stabilizer and inner valve stem extension.

5. If the valve stem extension is rubbing the side of the wheel opening, shown in [Fig. 1](#), reference A, gently swivel the inner valve stem so that it aligns with the center of the wheel rim opening. The valve stem should swivel with little resistance.

6. If the inner-wheel valve stem extension is rubbing at the top of the wheel rim opening, shown in [Fig. 1](#), reference B, or if the valve stem stabilizer is dislodged, remove the stabilizer and inner-wheel valve stem extension. Slide a small diameter tube over the end of the valve stem, then gently adjust the angle of the inner-wheel valve stem by bending it so that it aligns with the center of the wheel rim opening. If adjusting the inner-wheel valve stem resolves the issue, go to step 10.
