RECALL CAMPAIGN

CR4963E

REFERENCE:	Nova Bus Manuals
SECTION:	09: Engine and Cooling
RS N°:	MQR 7621-2169
EFFECTIVE IN PROD.:	N/A
TC RECALL Nº:	2021-057
NHTSA RECALL N°:	20V568

SUBJECT:	Power Steering
JUSTIFICATION:	Certain power steering pipes may separate at the connection joint. This may cause a power steering assist lost and power steering fluid spillage from the ceiling in the cabin.

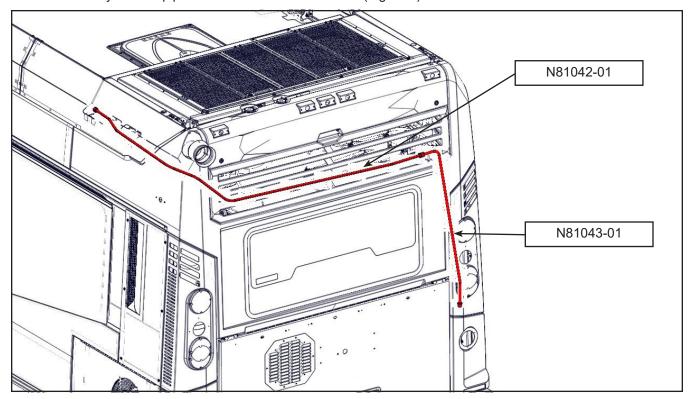
Figure 1 - Hydraulic Pipes N81042-01 & N81043-01

- 1.1. Park the vehicle on a level surface with the transmission on neutral.
- 1.2. Apply the parking brake and set the master control switch to the *stop* position.
- 1.3. Locate hydraulics pipes N81042-01 and N81043-01 (Figure 1).

- 1.4. On both pipes N81042-01 and N81043-01 search for manufacturers label:
 - a. If the label looks like the label shown in Figure 2, the pipe does NOT have to be replaced.
 - b. If the label looks like the label shown in Figure 3, the pipe **must be replaced**.
 - c. If no label is visible, the pipe must be replaced.

- 1.5. According to the inspection result, if 1 or 2 pipe have to be replaced, order replacement parts and proceed with procedure in LEVEL 2.
- 1.6. If the pipe does not need be replaced: this service document is completed. The vehicle can return in service.
