Subject: BMW 20V-xxx: Encode Control Units (Rearview Camera)

SIB 66 14 20

RECALL 20V-XXX: ENCODE CONTROL UNITS

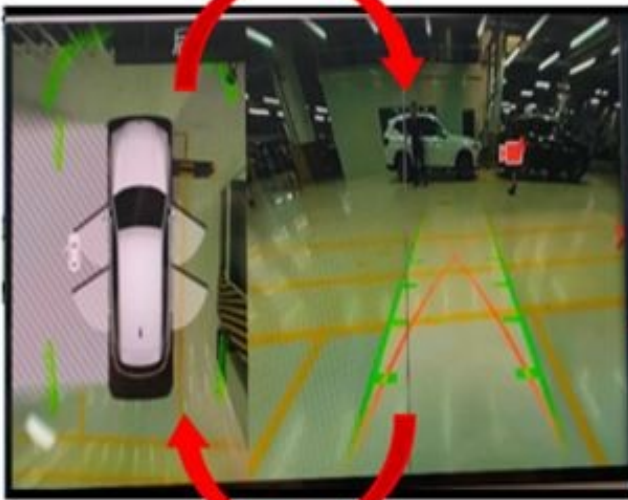
This picture shows the top view and rearview images which are **incorrectly displayed** in the wrong position (swapped) on the CID.

Software coding error in the ICAM control unit.

Encode the ICAM control unit with ISTA 4.25.3x (released September 25, 2020) or higher.

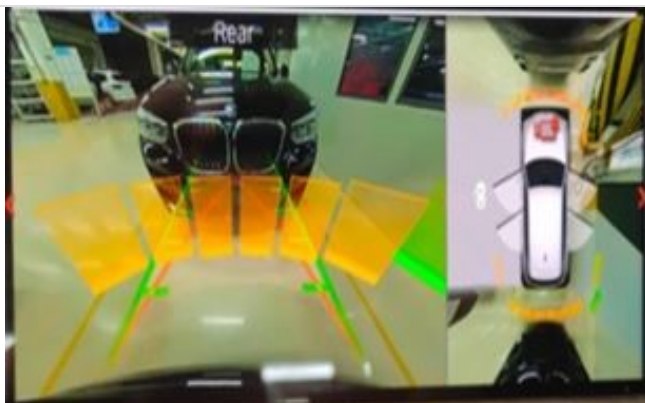
Here the images are displayed in the **correct position** on the CID.
