SIB 66 14 20

2020-11-02

RECALL 20V- 598: ENCODE CONTROL UNITS (REARVIEW CAMERA)

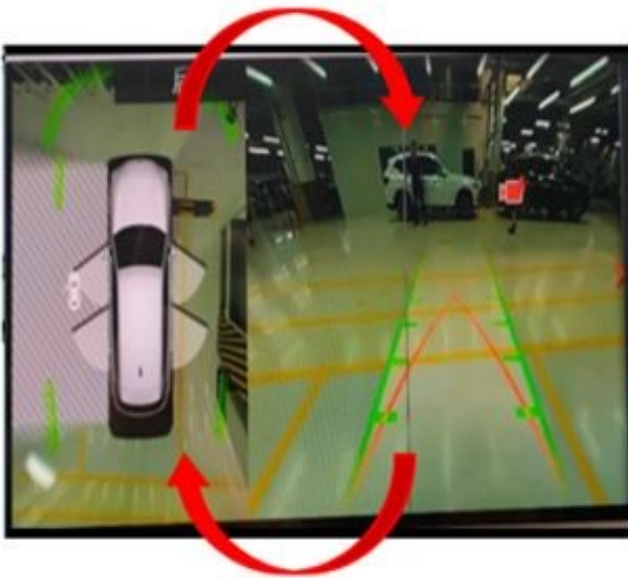
This picture shows a possible failure in vehicles equipped with option 6U3 (Live Cockpit Pro - incl. Navi).

The top view and rearview images are **incorrectly displayed** in the wrong position (swapped) on the CID.

Software coding error in the ICAM control unit.

Encode the ICAM control unit with ISTA 4.25.4x (released October 8, 2020) or higher.

10. If the image does not match picture 2, then recode the ICAM by repeating steps 5 – 9 above.

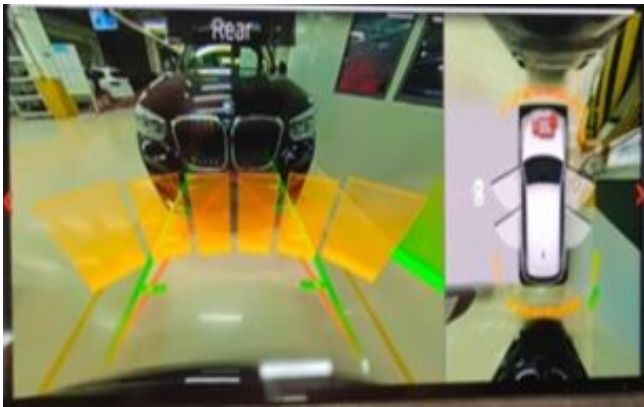
Here the images are displayed in the **correct image position** on the CID for vehicles equipped with option code 6U3 (Live Cockpit Pro - incl. Navi).

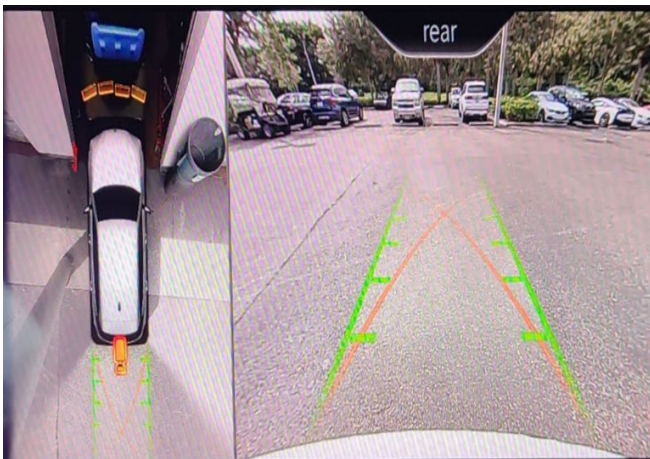
This picture shows the **correct image position** for vehicles without option code 6U3.
