SIB 61 23 20

2021-02-10

RECALL 20V-601: HIGH-VOLTAGE BATTERY RECALL

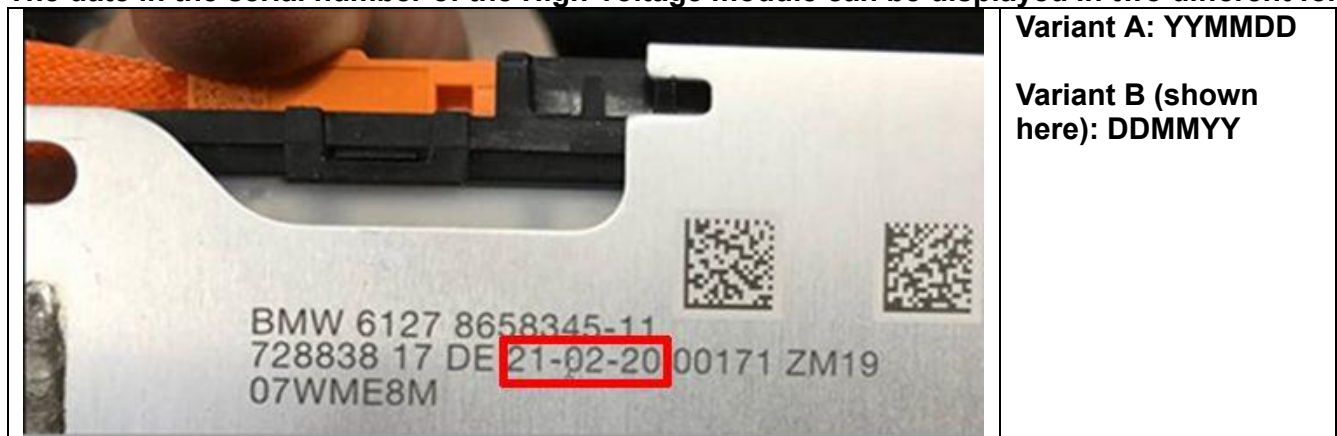
The date in the serial number of the High-voltage module can be displayed in two different formats:
