## SIM 61 07 20

#### RECALL 20V-601: HIGH-VOLTAGE BATTERY

Service Information Bulletin (Revision 1) replaces SI M61 07 20 dated November 2020.

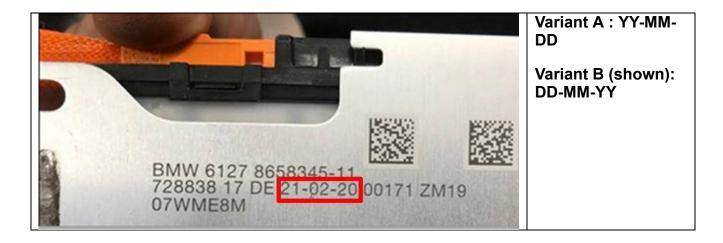
The date in the serial number of the high-voltage module can be displayed in two different formats.
